MAYNARD, MASS  
UNDERGROUND PIPE REPAIR

## MAYNARD, MASS. UNDERGROUND CAMERA INSPECTION LEADS TO PROPER STORMWATER ASSET REMEDY

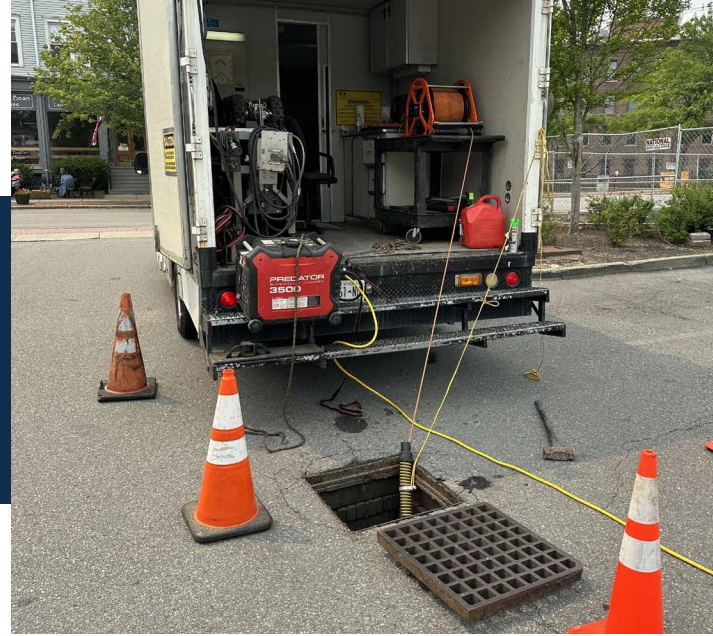
Through CCTV, AQUALIS inspected over three hundred feet of pipe to identify where infrastructure was compromised once it was cleaned. The camera investigation showed leaching as external water seeped into the stormwater pipe. Leaching is a type of corrosion where the pipe degrades over time and the metal begins to thin, allowing materials to flow either into or out of the pipe. In addition to this, the camera found places where joints had separated and fractured allowing a flow of groundwater to enter and carry high levels of contaminants downstream.

To repair the structural integrity of the pipe in a cost-effective manner, AQUALIS used a technique called pipe lining, commonly referred to as CIPP (curing in place pipe). Lining the length of the pipe effectively stops all entry points of contamination without replacing hundreds of feet of pipe. To line the pipes, a thin liner was inserted into the pipe and carried to the downstream access point. Once properly laid inside, air was pushed through the liner causing pressure to push the liner snug along the inside of the pipe. The liner was cured in place with resin which created a new barrier protecting the pipe from any external water. This choice is more efficient than replacing pipe as it can be done without excavation or entry. The liner can be made of various materials, often polyester or carbon fiber. The repaired pipe is now resistant to corrosion and all fractures and separations are sealed.

After the new cured in place pipe (CIPP) was installed, AQUALIS reinspected the area with additional CCTV to ensure the repair was successful. Visualizing the infrastructure after each phase of work ensured that no issue was overlooked, and all stages were successful.
