## SLOPE COLLAPSE

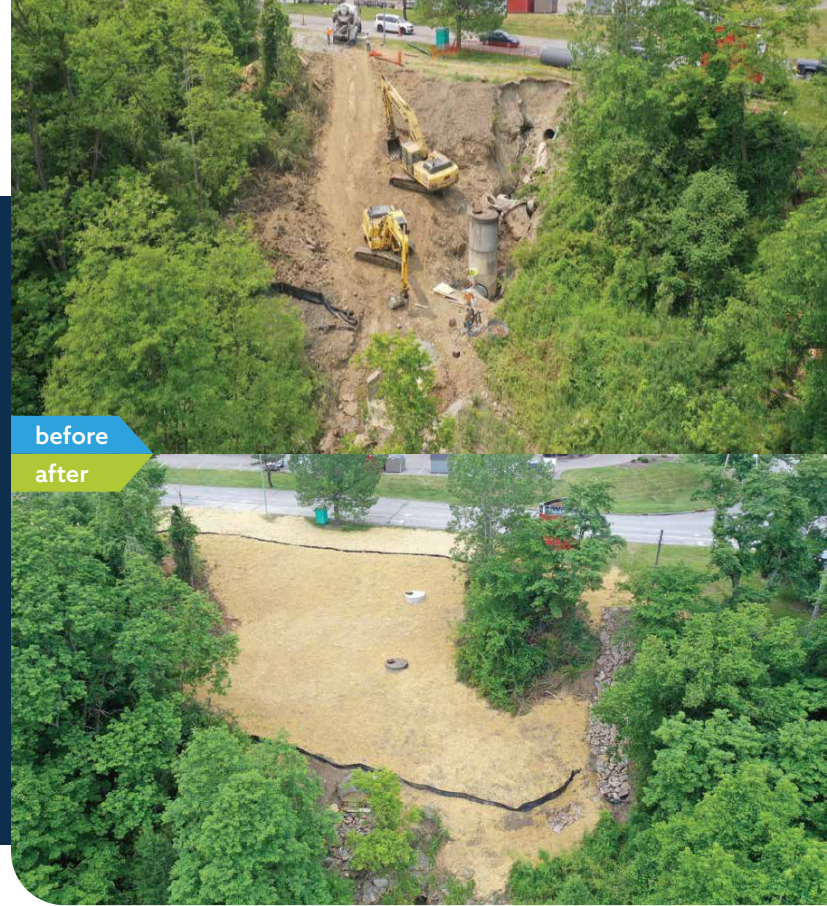
This property had a steep hill at the end of the parking lot that drained to a retention pond below. The underground stormwater system conveyed water from the parking lot to the catch basins and then underground to the retention pond. The underground stormwater system, responsible for conveying water from the parking lot to catch basins and then to the retention pond, had suffered damage over time. Years of intense rain events and high-water flow led to the failure of the stormwater pipe. Separations in the pipe allowed for sediment from subgrade outside the pipe to rush into the pipe, creating voids or holes on the surface level. This process accelerated with rapid water flow, eventually impacting the upstream pipeline, junction box and the nearby wastewater pipeline. As the sinkhole grew, it compromised the wastewater line which ran perpendicular to the stormwater line and slope. The sanitary line was soon compromised by the soil collapsing and broke, allowing waste to flow downhill and into the retention pond.

The sinkhole expanded causing the broken pipelines to flow freely into the retention pond, creating a health hazard. AQUALIS acted quickly, plugging both pipelines temporarily and implementing bypass lines and pumps for accurate inspection. Pipe inspection is done by a small robotic camera called CCTV that traverses inside the pipe, recording the interior condition. Deploying CCTV to assess the damage in the stormwater pipeline, AQUALIS found the upstream pipes were fortunately unaffected by the collapse and therefore did not need to be replaced or repaired.

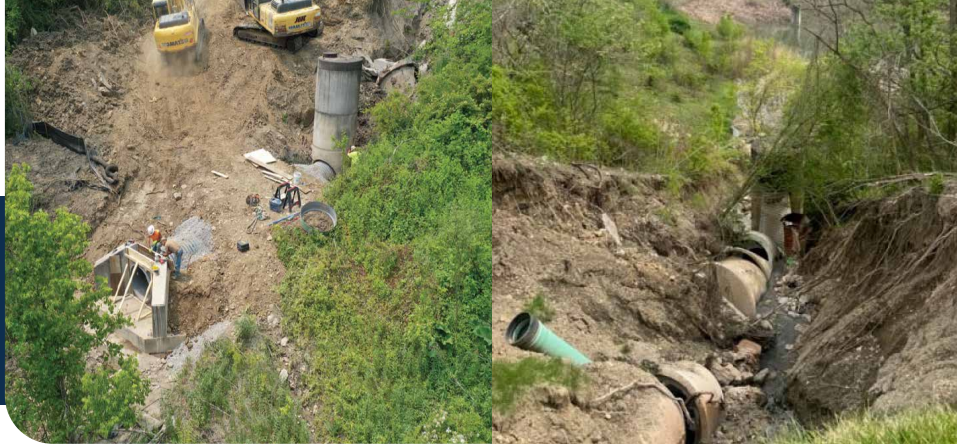
The property's original design incorporated junction boxes to create steps in the pipeline to account for the severity of the grade from the parking lot to the retention pond. Shorter sections of pipeline are connected by junction boxes that allow for significant change in elevation without dramatic pipe slopes. This is done to avoid slopes that accelerate the velocity of water. Increased velocities exacerbate existing issues more quickly than normal or reduced flow. On this site, a section of pipe between two junction boxes failed. Once the sinkhole appeared, the downstream infrastructure was directly affected. With excess water no longer contained in the pipeline, the

water rushed along the slope washing out sediment and the lower pipe sections. Erosion is an exponential problem and will worsen quickly. With combined flow now released down the slope, washout was significant.

The bypass lines had to be buried to allow for heavy machinery to access the site. Then, excavation could begin. Using heavy machinery, AQUALIS removed loose soils, damaged pipeline and junction boxes. Junction boxes are precast structures that are installed to allow for change in direction, elevation and various pipe sizes. The stormwater pipe was originally corrugated metal pipe (CMP) which has a shorter lifespan and is prone to rust and corrosion. Downstream, at the outlet at the end of the pipeline, a headwall was originally installed to prevent erosion. Headwalls are concrete structures cast around inlets and outlets to act as a barrier or retaining wall. At this site, the backfill behind the headwall had washed out from the high-velocity flow. The headwall was still intact, but the pipe inside was replaced. The CMP was replaced with longer lasting high-density polyurethane (HDPE) pipe.

The collapsed manhole was replaced with a new precast structure. Pipe bedding was laid to reduce the load on top of the new pipeline. A total of sixty linear feet of stormwater pipe was replaced to connect the upstream system to both junction boxes and finally the outfall. Interior and exterior connections were sealed with concrete collars and hydraulic mortar.
