DURHAM, N.C.

SINKHOLE LEADS TO STORMWATER SYSTEM REHABILITATION

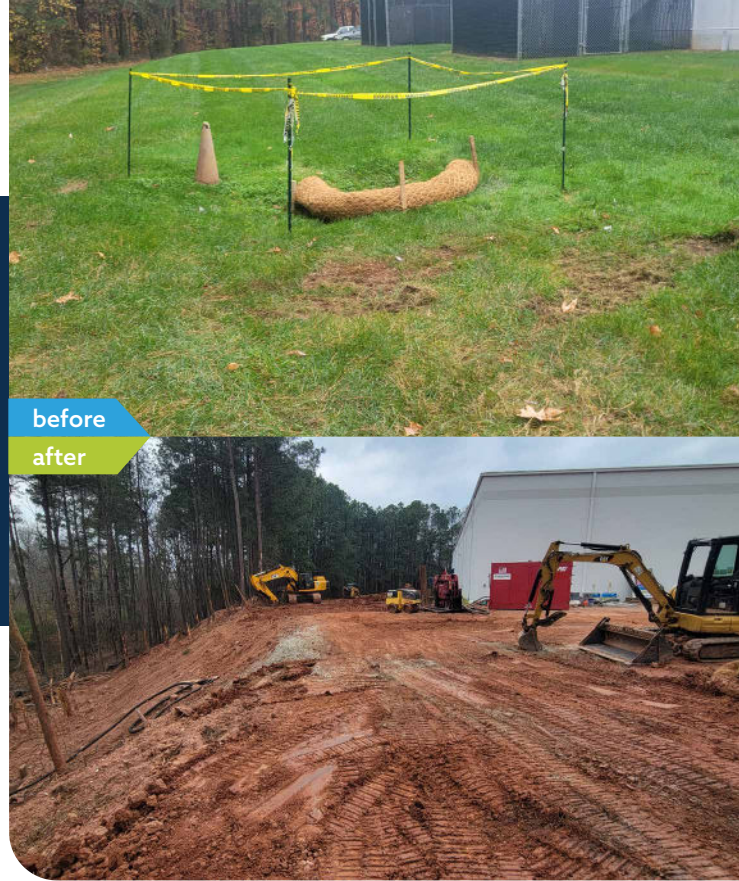
The sinkholes, coupled with severe erosion along the slope, meant extensive damage had occurred to the stormwater infrastructure below. The slope was eroded so severely that the stormwater infrastructure was exposed. Mature trees and the connected root systems prevented the slope from completely collapsing.

This system failed due to multiple circumstances. The mature trees were suspected to be involved in the decay of the infrastructure as the root systems were extensive and entangled around the pipes. However, the junction boxes and pipelines were dangerously aged and not regularly maintained, shortening the lifespan of the infrastructure. Severe slopes often exacerbate erosion as water rapidly gains speed, loosening sediment. Additionally, the surrounding soils were unstable and not sufficiently compacted meaning they were highly susceptible to erosion and potential sinkholes. Together, all of these factors led to serious decline of the stormwater system on this property.

before
after

AQUALIS established bypass lines for the stormwater system to maintain functionality throughout the repair. The concrete pipeline was severely eroded, leaving large holes as it collapsed. The original junction boxes were created from brick. While this may have been an approved method in the mid-80's when the system was originally developed, it is no longer recommended as cast-in-place and/or pre-cast withstands overtime. The joints that originally connected the pipeline and the junction boxes had failed. The failed junction box was removed, and the new junction box was cast in place using concrete. The second junction box was repaired and reinforced with grout and concrete. The new pipeline was then laid. Every joint of the pipeline was reinforced with additional concrete to prevent future seepage. The concrete headwall was then repaired.
