PREVENTATIVE MAINTENANCE PROTECTS ASSETS

Regular maintenance of stormwater assets protects properties from failures related to buildup and structural issues. Routinely inspecting and maintaining these assets can prevent costly repairs. This client is required by the local municipality to inspect and repair the stormwater system on their property to full compliance every five years. During this regular inspection, defects were found and remediated before more serious issues surfaced.

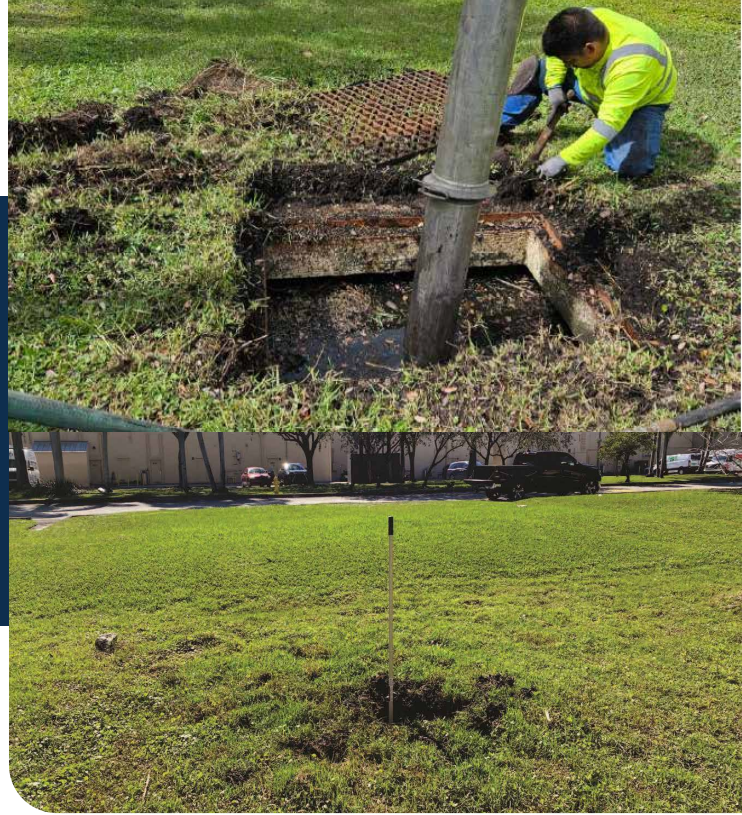
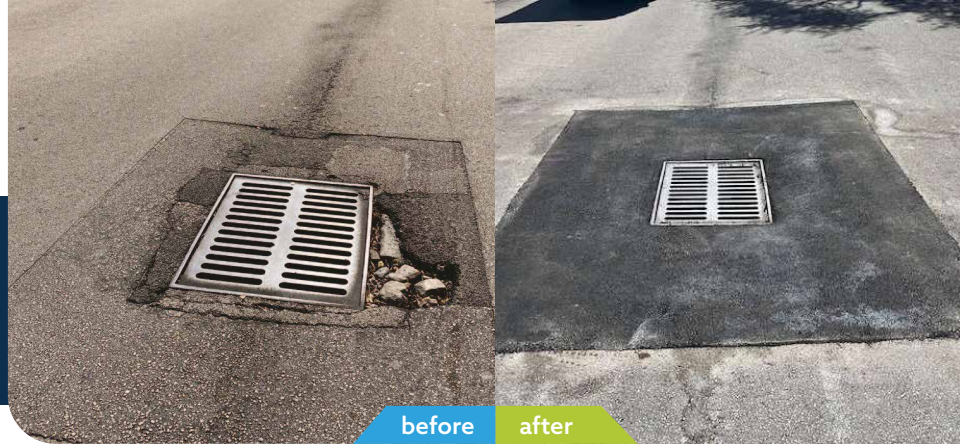
After the initial inspection of this site, multiple maintenance and repair needs surfaced. Per requirements of Broward County, material or debris inside a pipe shall not exceed 5% of the diameter of the pipe and the material in the catch basin shall not exceed 5% of the distance from the bottom of the structure to the lowest pipe invert. This stormwater system did not meet these requirements and therefore needed to be serviced. Additionally, fractures were found inside and around multiple catch basins that needed repair.

For this property, industrial vacuumation and jetting was the preferred method to clean these stormwater control measures and avoid dewatering. The stormwater assets on this site were laden with sediment and debris preventing them from properly conveying the stormwater. The assets on the property include 43 catch basins and 4 bubble up structures.

Next, the catch basins could be repaired. The area around catch basins is called the apron. It offers additional structural support and is often sloped to convey water toward the grate. On this property, some aprons around the catch basin had begun to deteriorate. To repair aprons, the surrounding area is demolished, excavated and regraded. Asphalt or concrete is then poured into the area to the specifications of the original design.
