DURHAM, N.C.

## SYSTEMATIC NEGLECT LEADS TO REHABILITATION

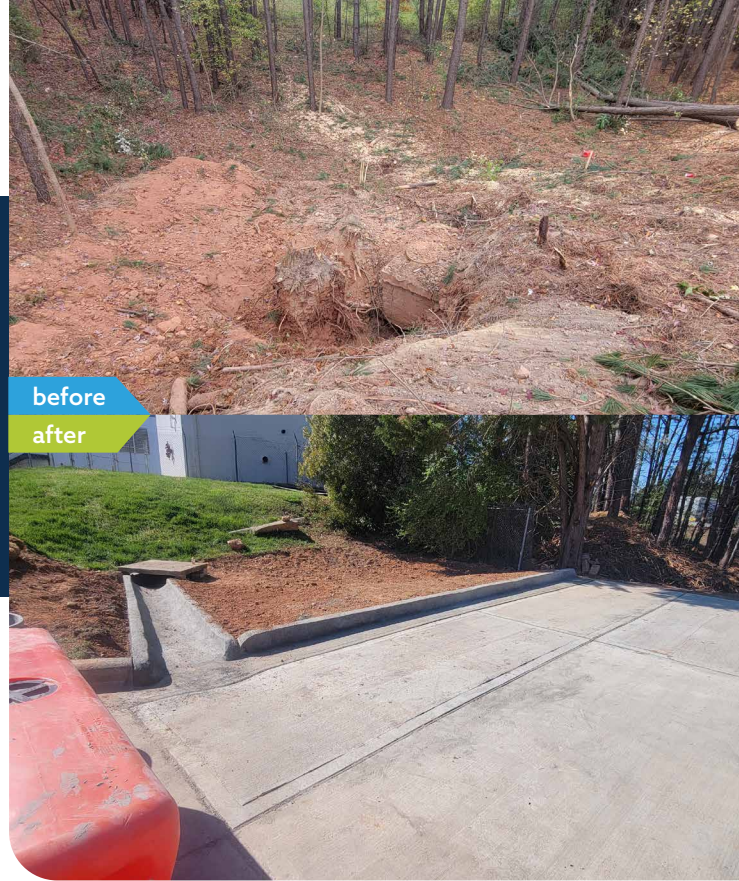
To understand the extent of the necessary repairs, AQUALIS had to thoughtfully clear the area. First staging necessary construction BMPs (Stormwater Best Management Practices) and temporary stormwater bypasses to protect the property and downstream ecosystems from excessive construction sediment or debris. Then the fence at the edge of the parking lot was removed to allow access for heavy machinery. Mature trees within 10-15 feet of the stormwater system were cleared and mulched. This allowed AQUALIS visualization of the damage. Multiple four-foot root balls were found along the pipes and junction box. As the trees grew, the root systems expanded into the infrastructure and disjointed connections creating large voids in the system leading to sinkholes at the surface.

before  
after

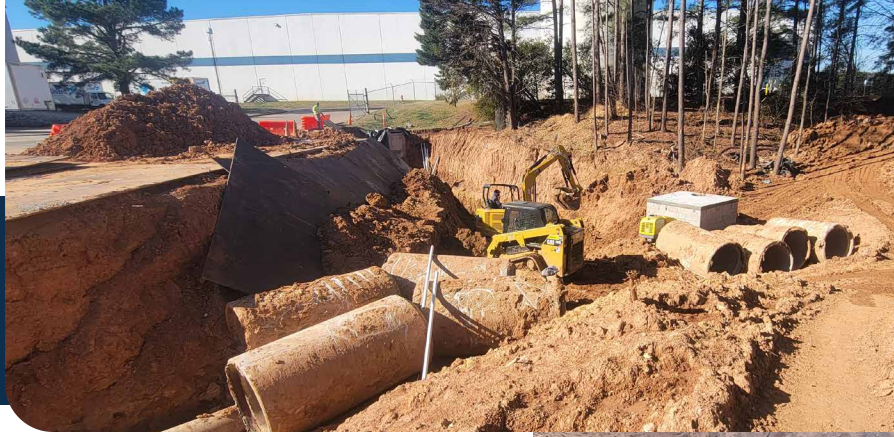
The soils in this area were not the necessary engineered fill that is chosen to protect underground infrastructure and meet acceptable compaction rates, instead the surrounding soils were soft and unsuitable for protecting the pipelines. The soft soils allowed additional shifting of the components, misaligning connections and destabilizing the junction box.

Junction boxes are stormwater assets that act as a connection point for pipeline. The junction box had suffered such severe fracturing from the root balls and sediment shifting, that removal and replacement was the most logical choice for the integrity of the stormwater system. Three additional junction boxes were inspected and required minor repairs.

AQUALIS began excavating the area to remove the root balls and unsuitable soils to allow access for repairs. To ensure the surrounding parking lot did not suffer damages during construction, the concrete parking pads within the limited area of disturbance were removed. This ensures the entire compromised parts of the system could be removed safely and the area could be properly regraded and compacted.
