AUSTIN, TX.

CURED IN PLACE PIPE

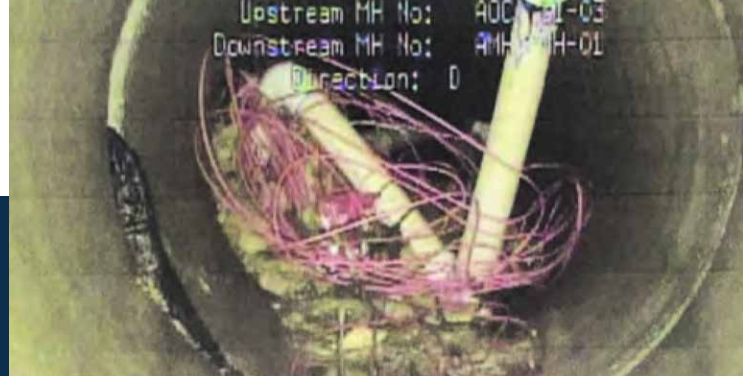
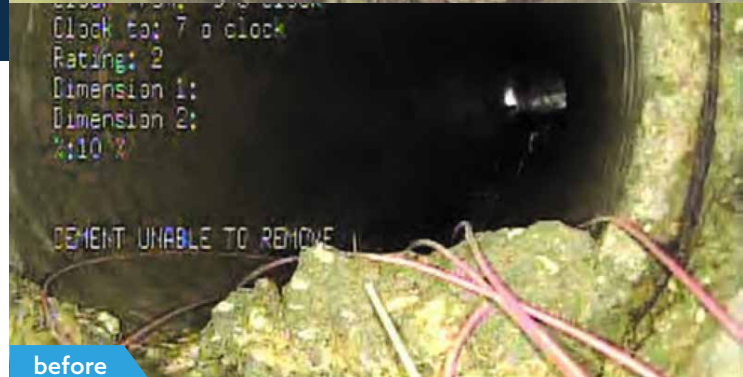
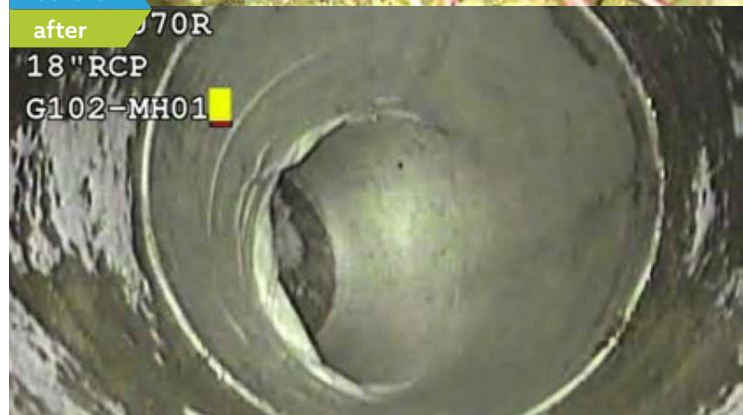
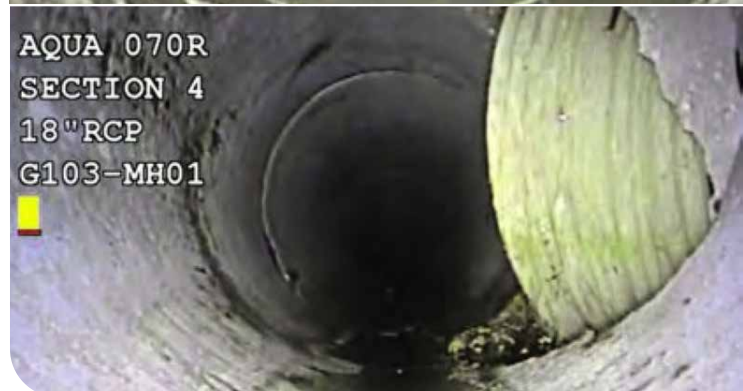
During the camera investigation, the operator found extensive blockages inside the pipeline. Construction debris, including PVC pipe, wires and concrete, had been deposited inside the pipe, significantly reducing capacity, leading to clogging. Because of regular clogging, the pipe was under consistent stress that rapidly deteriorated the infrastructure. In addition to the wire and PVC pipe that was found, significant damage and concrete debris was found as the pipe crumbled from the inside.

The pipeline, made out of reinforced concrete pipe (RCP), was experiencing failure so great, the rebar reinforcements inside the concrete were visible. The internal rebar was beginning to corrode resulting in further damage to the structure. Large gaps were visible between sections of pipeline, allowing surrounding sediment into the pipeline and to the retention area downstream. This process is the leading cause of sinkholes as rushing water displaces the dirt creating a cavity that eventually opens at the surface.

AQUALIS CCTV Pipe Inspections follow the industry standard rating scale of 1-5 as set by NASSCO. Significant defects that require immediate attention are labeled 5 while minor issues are labeled 1. The pipeline assessment showed four different sections of about four feet each that required immediate repair. To avoid replacing the entire pipeline, cured-in-place-pipe (CIPP) repair was chosen, allowing for small spot repairs.

Once the initial CCTV assessment was conducted and the obstructions were identified, the operators had a better understanding of how to complete the repair. Industrial vacuumation and jetting was sufficient for removing the concrete debris and PVC pipe, but a root cutter was deployed to cut the wires. After the pipe was cleared, the repair could be performed.

CIPP allows for trenchless point repairs, significantly reducing construction costs. CIPP repair is performed by inserting a resin coated liner into the existing pipe. The liner

is then inflated to cover the internal wall of the pipe, it can then be cured with steam, water or UV technology. Using CIPP to patch repair this pipe saved the property from fully replacing the pipeline and extended the life of the infrastructure another 50 years with maintenance.
