TACOMA, WASH.

LEAK REPAIR WITH HYDRO-EXCAVATION

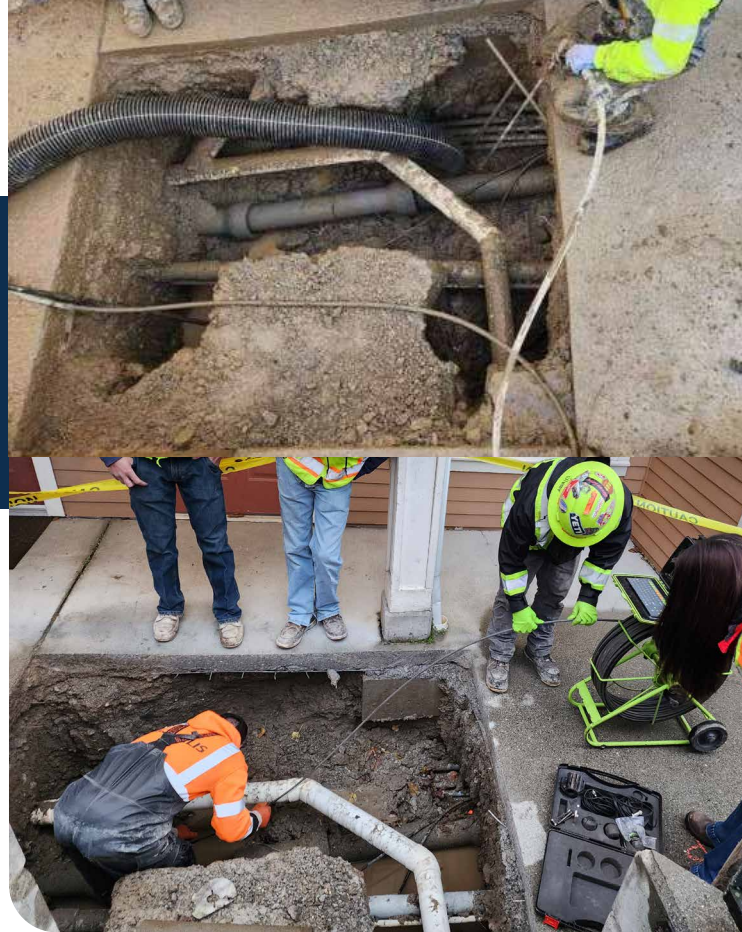
The AQUALIS team began by installing shoring and protective barriers around the affected area to safeguard the building and its surroundings. Additionally, traffic barricades were placed to ensure the safety of both crew and customers, emphasizing AQUALIS' commitment to maintaining a secure work environment. The team then used jackhammers to remove large chunks of concrete from the area. Once concrete was removed, dirt and gravel were exposed. The team was then ready to start the hydro-excavation process. Hydro-excavation is used to clear out soil, grit and other materials located near underground infrastructure. Pressurized water is used to break down the soil and a powerful vacuum collects everything into a holding tank. Once the hydro-excavation was completed the problem was clearly identifiable at its source. The old concrete sewer pipe under the gravel had a leak that needed to be sealed.

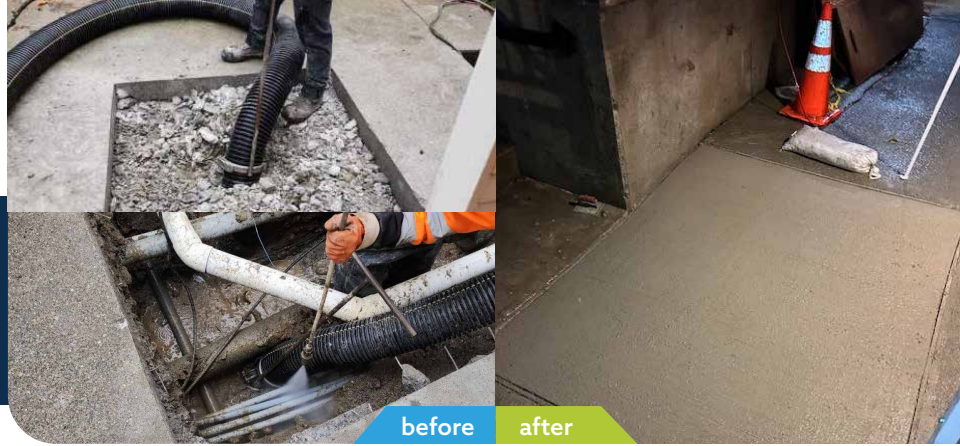
At the first location a leak was located near the end of the concrete pipe, which initially

suggested the need for further evaluation at a second site. Upon hydro-excavating the second location, a pocket of water was quickly discovered, confirming the presence of a leak. Further inspection revealed that a crack in the coupler fitting was the root cause of the issue. The damaged pipe was promptly repaired, restoring proper water flow and effectively eliminating leaks and draining issues from inside and around the building.

After completing the necessary pipe repairs, the open hole was repaired by backfilling and compacting the soil in layers, ensuring a stable and secure foundation. Once the backfilling process was completed and the area has been thoroughly compacted, the next crucial step involved constructing a reinforced cage. This structural component is essential for providing additional support before the reapplication of concrete. To accommodate natural expansion and contraction due to temperature fluctuations, joint expansion material was carefully placed, allowing the concrete to flex appropriately during hot weather conditions preventing cracks or structural damage over time. Finally, the surface of the sidewalk was restored, eliminating any safety concerns.
