KIRKLAND, WASH

## ROOT INFILTRATION & FLOODING MITIGATION

The property manager at this site identified continual ponding indicating drainage failure related to the stormwater system. AQUALIS was called to identify the root cause of the flooding and repair the failure.

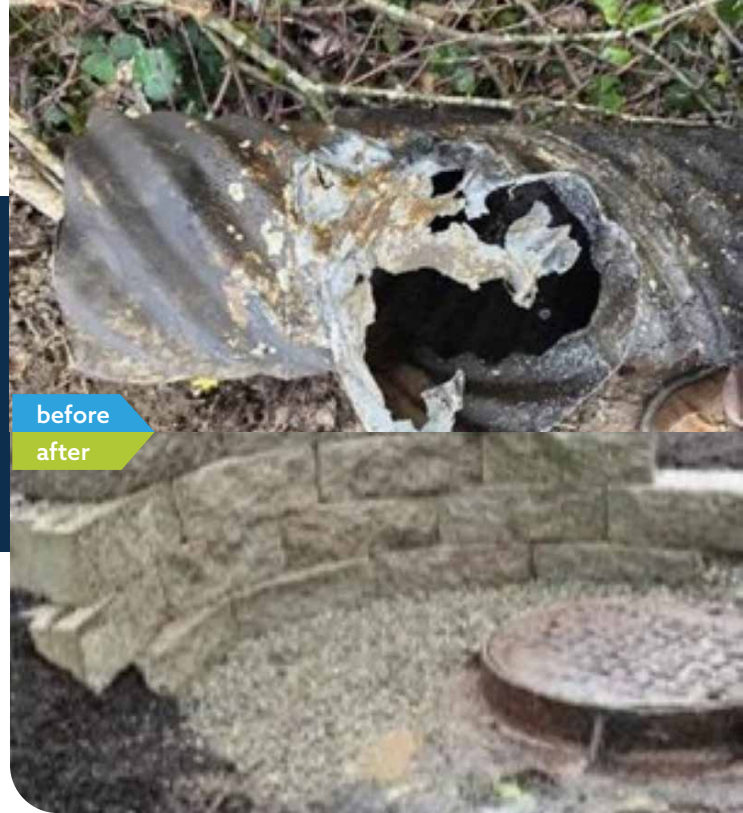
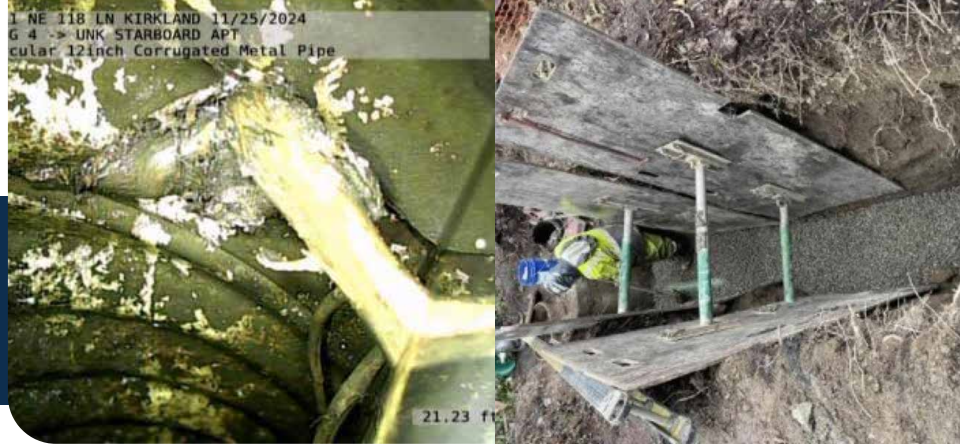
Due to the location and nature of the property, AQUALIS utilized the local utility location company to identify underground utilities. During this search, a buried manhole cover was located under approximately two feet of soil. Buried manholes restrict access to the pipe and indicate significant soil disruption. After excavating and clearing the area, the team began inspecting the pipeline, starting with the upstream section. They used CCTV (Closed-Circuit Television) to assess the pipe's condition. This method allowed the team to view internal pipe damage with minimal disruption to the surrounding area. During the inspection, they identified extensive damage caused by invasive tree roots and corrosion. Roots had penetrated the pipe, creating an opening for water to flow in or out of the pipe freely, disrupting proper water flow. Root intrusion is one of the most common reasons for pipe failure. As trees and bushes grow, their root systems expand underground compromising infrastructure like this stormwater pipe.

Once the buried manhole was excavated and the area was regraded, the downstream pipe could then be evaluated. Upon this inspection, additional damage was found, confirming the need for a more comprehensive repair. During the inspection process, the team also uncovered that the flow control device inside the stormwater vault was significantly deteriorated and no longer functioning as intended. Flow control devices are often installed inside stormwater vaults to function as a capacity valve that can be manually overridden. Normally, the control device allows the approved amount of stormwater overflow but in extreme circumstances can allow for the vault to be emptied or filled further.

The team began with the upstream pipe, cutting and excavating the identified areas of pipeline failure. Due to the extensive damage to the pipe, non-invasive repairs were not feasible, and the pipe had to be replaced using traditional trenching methods. Excavated soil was placed on a designated pad to be reused later during backfilling, to eliminate sediment runoff. Once daylighted, the damaged pipe sections were carefully removed and disposed of at an approved off-site facility.

The team determined that the best resolution was to replace all damaged sections of Corrugated Metal Pipe (CMP) with new Polyvinyl Chloride (PVC) pipe. PVC was chosen as it is thicker than CMP and therefore more resistant to root intrusion and as it is plastic; it is less likely to corrode in the conditions of this property.
