## AGING INFRASTRUCTURE

Multiple catch basins on a property were due for repairs as a result of damaged and aging infrastructure. These issues not only posed a safety hazard but also risked further damage and possible flooding. AQUALIS team members were able to implement repairs that restored functionality, enhanced safety and extended the lifespan of the system.

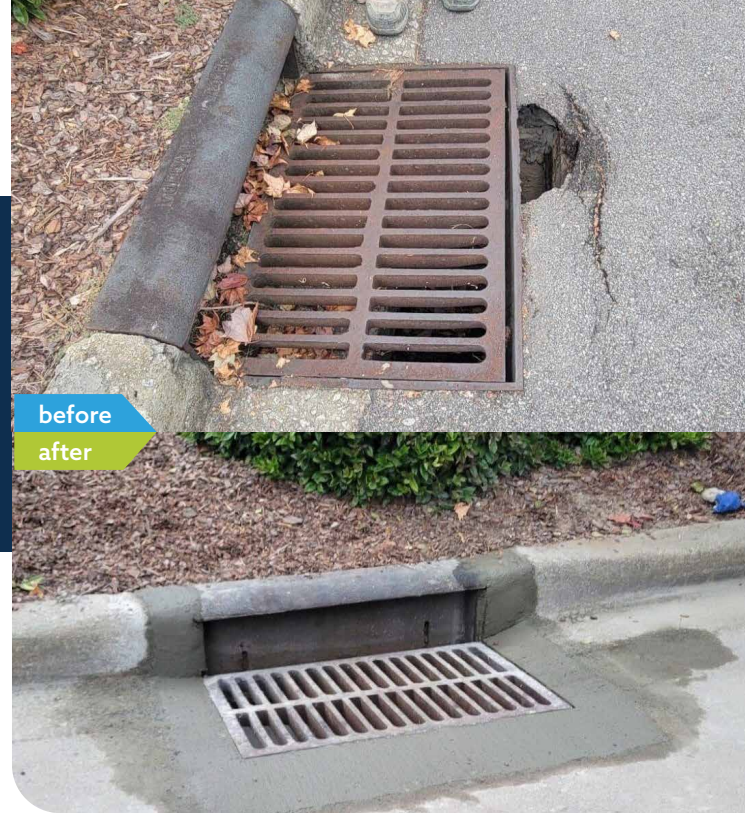
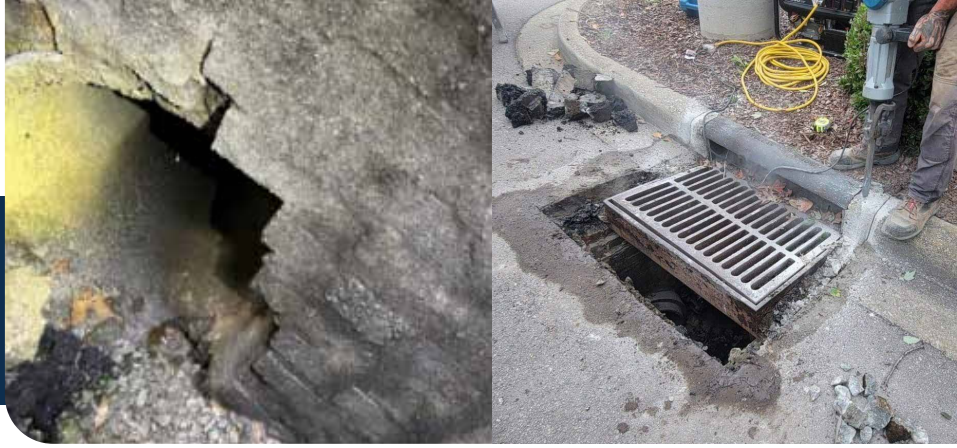
The concrete at the front of one of the catch basins had significantly deteriorated, causing loose asphalt fragments to fall directly into the junction box below. The degradation created an opening on the surface, presenting a safety hazard with the potential for pedestrian trips or falls. Additionally, the opening allows debris, sediment and trash to bypass surface filtration and enter the stormwater pipes below, which can contribute to blockages and inefficiencies. The surrounding pavement also shows signs of structural compromise due to the ongoing asphalt deterioration, further highlighting the urgency for repair. This occurs often, especially in high traffic areas like parking lots and curbs. Years of vehicles driving over these metal grates result in settling and eventual deterioration.

Multiple catch basins on this site suffered similar wear, which is to be expected as the infrastructure was installed at the same time. Stormwater assets, like all infrastructure have expected lifespans. Without maintenance and corrective repairs, these problems worsen, ultimately shortening the lifespan of the asset. Small cracks, when caught early like this instance, can be repaired quickly before full failure or a notice from the city is received.

AQUALIS started the repair process by securing the project area to ensure safety and prevent disruption to business operations. A wet saw was used to cut the existing asphalt and concrete around the catch basin, allowing for clean removal. The deteriorated material was then removed for proper disposal in accordance with environmental and site regulations.

The catch basin grate and frame were in working order and therefore could be reinstalled once the repair was completed. These catch basins were originally built with individual bricks laid to the appropriate height of the road. The bricks at the top of the structure were under the most pressure and began to fail. AQUALIS removed these failing bricks and laid additional concrete to add strength and structure to the area. This layer of concrete allows the stormwater professionals to meet the proper elevation, or grade, of the road which will ensure proper drainage. This technique helps in preventing water accumulation and maintaining system performance.

Compactable backfill material was then placed and compacted in layers to achieve the desired subgrade elevations. Once the subgrade was prepared, the catch basin frame was reinstalled, ensuring a secure and level fit. New asphalt/ concrete was then poured and finished around the frame, restoring the surface to its original integrity. Finally, the catch basin grate was reinstalled, marking the completion of the repair. AQUALIS fully restored the functionality of the system and area safety.
