## TARGETED RESTORATION

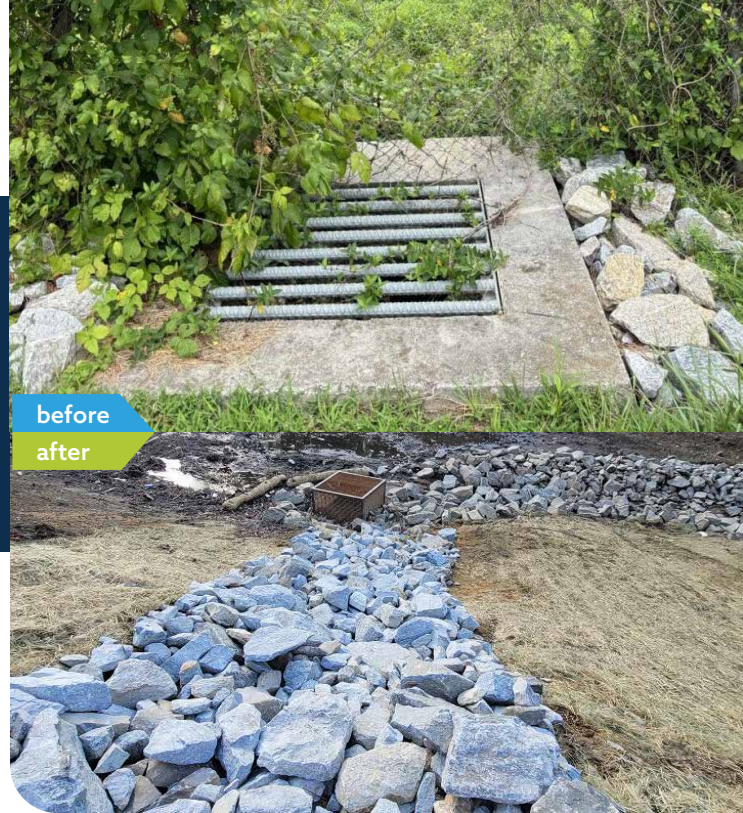
Following the initial work and a detailed review of the site drainage design plans, AQUALIS proposed phase 2 of the rehabilitation project to restore the system to original design. During remedial services and site investigation, AQUALIS identified several critical issues contributing to the system's underperformance. The OCS was obstructed by accumulated sediment and debris, which was impeding proper drainage. Additionally, the surrounding riprap had shifted and deteriorated over time due to prolonged lack of maintenance, leading to erosion and structural instability.

Compounding the issue, erosion around the flume and riser overflow, as well as vegetation overgrowth on the dam slope, had degraded the stormwater system. Erosion created instability, while excessive vegetation restricted access and added weight that could compromise the structural integrity of assets. These conditions created risks not only to stormwater compliance but also to the long-term safety and functionality of the site's infrastructure.

The team began with the OCS, using high-pressure water jetting to clear obstructions within the 8" outlet pipe that runs from the OCS to the upstream junction. This will allow for proper drainage from the basin.

Following the jetting process, the area around the OCS was excavated. Sediment within the pond accumulated around the structure reducing the capacity of the basin. The sediment within the basin was then redistributed to ensure positive drainage toward the the outlet pipe, enhancing the overall efficiency of the system.

To stabilize the area and protect the structure from erosion, non-woven filter fabric and rip rap was installed around the entire OCS. This strategy will not only allow water to run through effectively but also minimize the impact of soil displacement and preserve the integrity of the basin.
