## LIFT STATION PUMP REPLACEMENT

MANSFIELD, OHIO

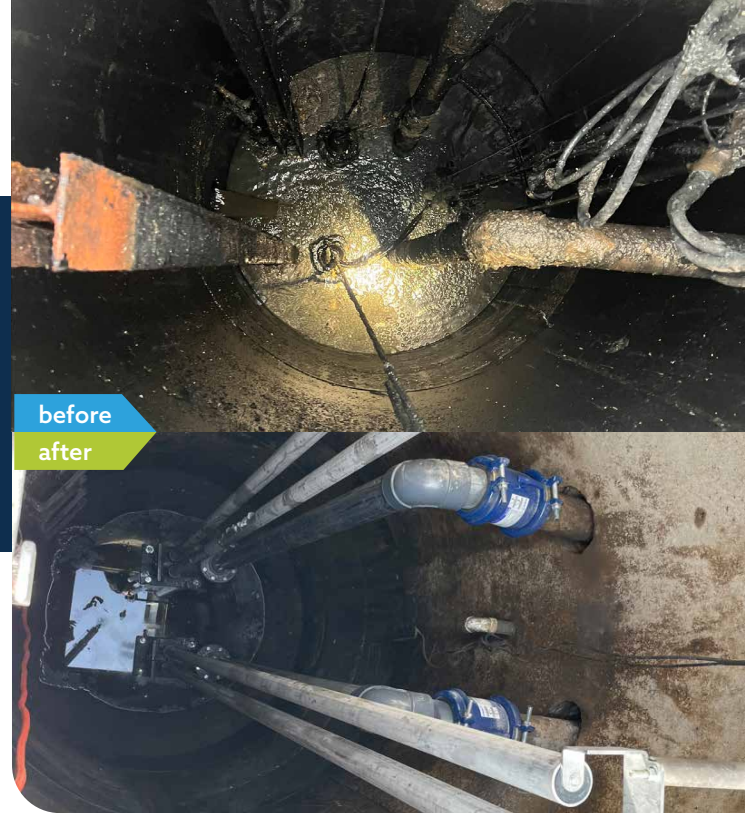
By the time AQUALIS was contacted to inspect the site, the situation was already urgent. The station was actively overflowing and required immediate bypass pumping to prevent further discharge of untreated wastewater. Upon the first inspection one pump had failed and the other was in critical condition. The second pump had burned out entirely and had to be removed. During the removal process, a significant amount of debris was extracted from pump one. This is an indication of lack of maintenance as debris was backed up.

- **Mechanical failure** of both pumps due to overuse, lack of maintenance and debris accumulation.
- **Poor solids management** in the upstream settling tank, which contained not only sludge but also compacted solids that a standard pump-out could not remove.
- **Aging electrical components** in the control panel, including worn contactors and overloads.
- **Degraded guide rails and base elbows**, making proper pump alignment and reinstallation difficult and hazardous.

Due to the severity of the failure, AQUALIS proposed a complete rehabilitation of the lift station to restore system functionality and regulatory compliance. First both pumps needed to be fully replaced. The original pumps were undersized and overworked, so high-efficiency pumps were chosen as replacements as they can move larger solids. These were better suited for the capacity of the property. Because the existing station lacked an effective base elbow and guide rail system, technicians installed a new system, including
