DESTIN, FLA

WEIR WALL REPAIR

A coastal property experiencing frequent flooding due to high tides and heavy rainfall had an aging outlet control structure that no longer functioned properly. AQUALIS collaborated with engineers to design and install a reinforced concrete weir wall, new footer and check valves to strengthen the system and prevent tidal backflow.

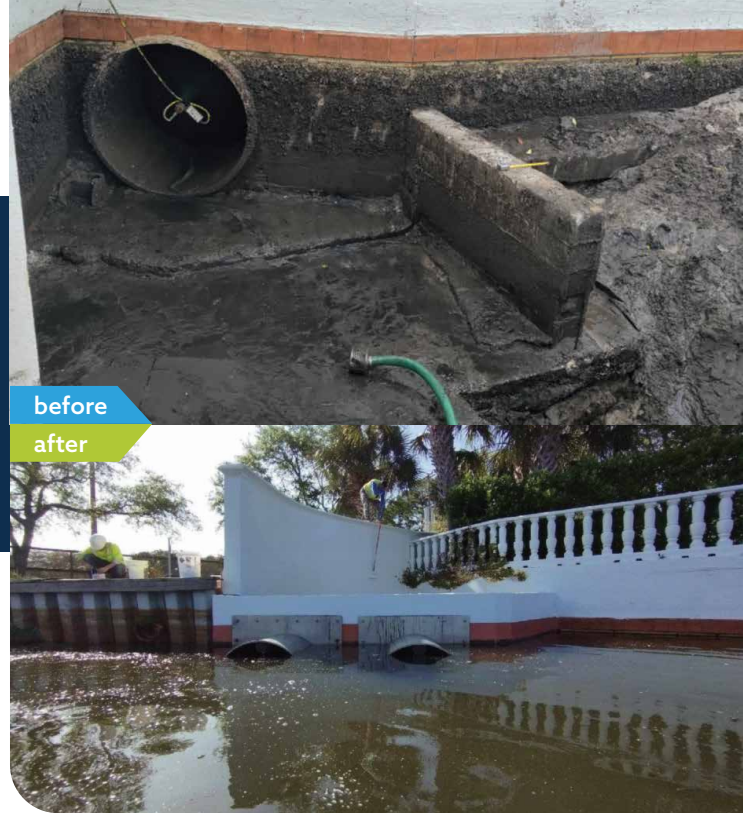
The property owners were in the process of retrofitting their stormwater system to replace aging infrastructure. Before construction could begin, it was necessary to verify the existing conditions. During the consultation phase, AQUALIS representatives walked the area of concern with property managers while reviewing the design plans. It was discovered that the current site conditions did not match the original construction drawings. This type of discrepancy is a relatively common occurrence when engineers and contractors do not coordinate closely. At this site, the outlet structure walls extended further than shown in the plans, the concrete base had different dimensions and lacked reinforcement and an undocumented wall was present in front of the outfall. The concrete base was also deteriorating rapidly.

Understanding the true conditions of the site was essential in developing an effective plan to repair the infrastructure and reduce flooding. Working with a third-party engineering firm, AQUALIS stormwater experts designed a stronger approach to reinforcing the outlet control structure. The solution involved the installation of a reinforced concrete weir wall, a new concrete footer and two check valves to prevent tidal backflow.

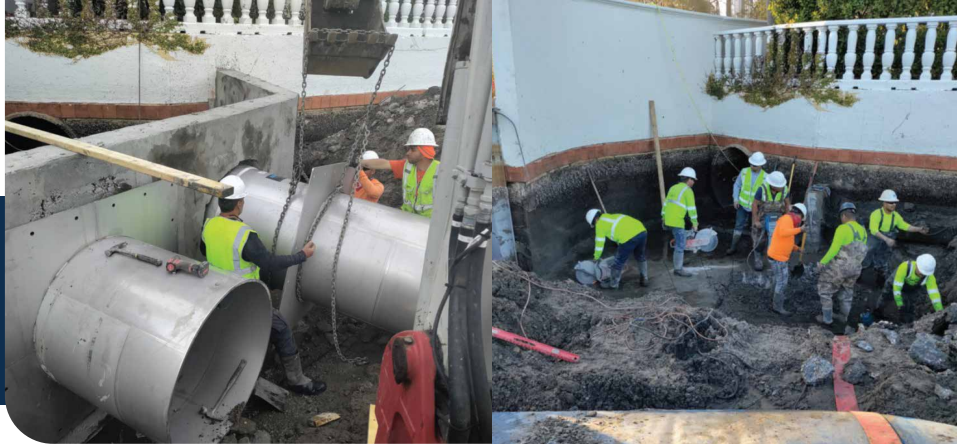
The first step was to dewater the area. Connected pipelines were plugged, and a temporary bypass system was established. A bladder plug was placed to contain the water in the lagoon, allowing access to the wall. During the dewatering process, significant erosion and structural weaknesses in the wall were observed, confirming the need for additional reinforcement. The team excavated the area to the subgrade, removing the old footings and the small wall in preparation for the retrofit. A reinforced concrete footing was then poured to withstand the hydraulic forces caused by tidal fluctuations.

Once the footing was in place, a wooden form and rebar cage were constructed to shape the new concrete wall. The design incorporated recesses for the check valves and connected securely to the existing wall with additional reinforcements. Check valves were chosen because they allow water to flow away from the property while preventing backflow. After the wall cured and passed watertight testing, the valves were installed.
