## FROM INSPECTION TO RESTORATION

The City of Morrisville conducted an inspection of an apartment complex and found several deficiencies and areas of concern within the stormwater systems. AQUALIS was brought in to quickly assess the situation and resolve the issue before it escalated further.

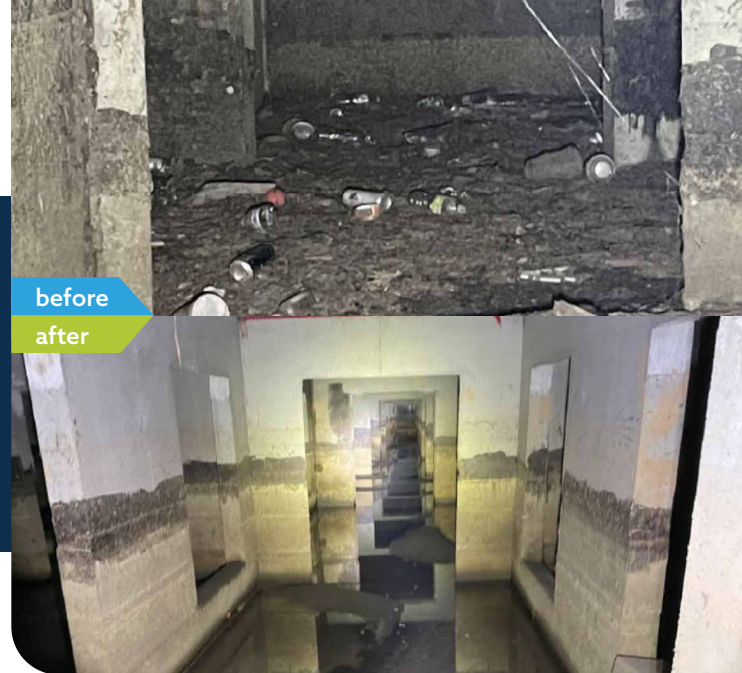
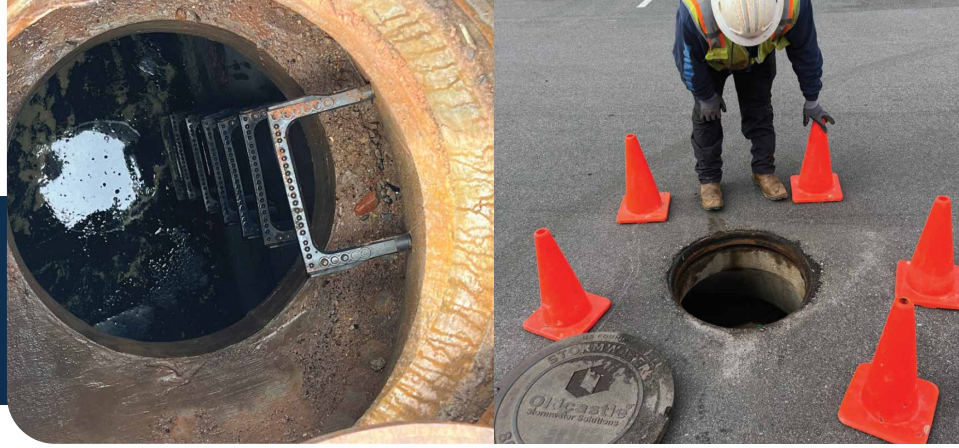
During an investigation at an apartment complex with the city's stormwater engineer, it was found that the stormwater chamber on site had experienced significant water loss. Later, this was determined to be caused by a large crack in the vault, allowing untreated stormwater to leak externally. The city's stormwater engineer recommended that the cracks be sealed to prevent further deterioration. The engineer also noted extensive vegetation overgrowth above ground, preventing proper water flow into the system.

In addition to the weir wall issues, a missing cleanout cap on the sand filter needed to be replaced. Without the cap, trash and debris had entered the filter, reducing its ability to remove pollutants and sediment runoff. Sand filters are designed to capture these materials before water leaves the property, protecting downstream waterways and preventing blockages in the system. The cleanout cap seals the opening of the sand filter while allowing maintenance crews to access the interior for cleaning, flushing and inspection. When damaged or missing, the filter is exposed to additional debris and odors, increasing the risk of failure. Replacing the cap was essential to restoring the site's water quality treatment, and the city recommended regular maintenance to ensure long-term performance and compliance.

AQUALIS' skilled team members began by using a jet Vactor combo truck to clean the sediment chamber, removing all accumulated sediment, trash and debris. Crew members also manually shoveled debris and sediment from the chamber to ensure detailed and thorough cleaning.

To address the structural concerns, all cracks were sealed to allow the system to hold water and prevent further damage. Once sealing was complete, the team inspected the area of dry concrete and elevation change to verify system integrity.

Next, the team turned their attention to the sand filter. Overgrown vegetation was trimmed around the outfall using weed trimmers, and all trash and debris were removed from the underground sand filter chamber. This was done to prevent covering of the structure and allow for optimum discharging of stormwater runoff. The cleanout cap was then replaced with a new one to restore full functionality.
