CHARLOTTE, N.C.

STORMWATER REPAIRS ENSURE COMPLIANCE

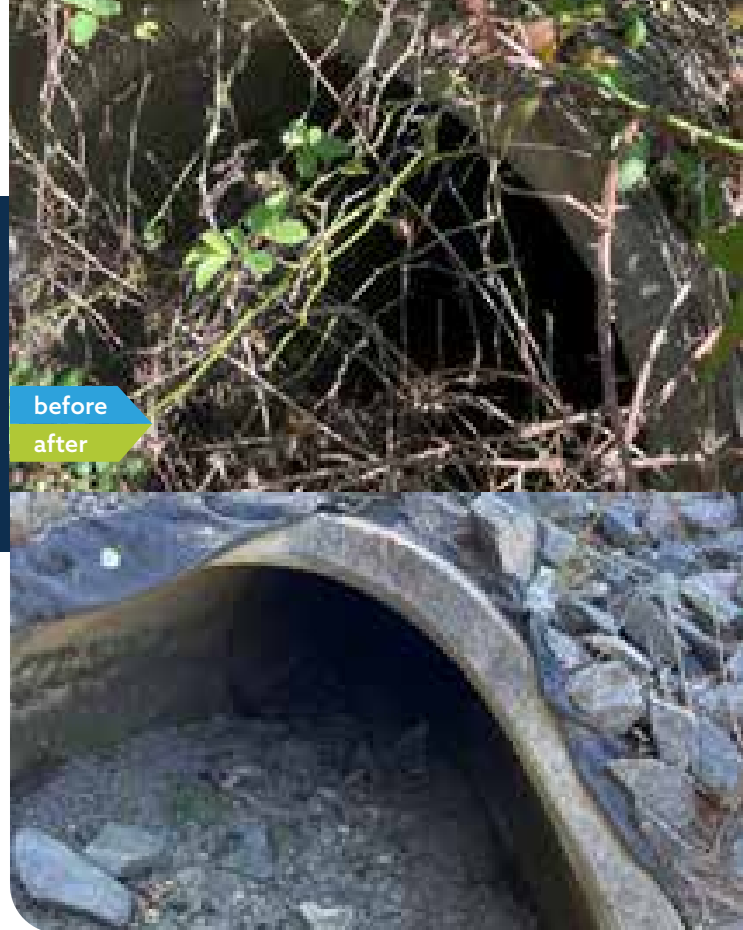
One of the key issues identified was sediment buildup at the inlet leading to the swale. This accumulation restricted water flow and created blockages, reducing flow capacity, especially during heavy rain events. If left unresolved, this can cause flooding and, over time, may result in more severe infrastructure damage to the pipe itself, such as corrosion, pipe sagging or joint failure. Additionally, the inlet concrete flume, which is designed to slow and guide runoff into the drainage system, had become obstructed by sediment buildup and was no longer effective. Built-up sediment in the area needed to be removed and the rip rap needed to be replaced to meet original design specifications and restore optimal performance.

Due to the sediment buildup around the inlet, the swale was also compromised. Sediment and woody vegetation covered the bottom of the swale hindering the capacity of the asset. The sides of the swale were bare, indicating runoff was destabilizing the slope and depositing sediment in the bottom of the basin. Without grass along the slopes, runoff is more likely to lead to erosion and the sediment will be deposited somewhere else inside the stormwater system. This is a common failure of stormwater systems.

Work began at the inlet structure, where a mini excavator was used to remove accumulated sediment and riprap. The swale was excavated to remove sediment and woody vegetation, then backfilled and compacted to restore proper elevation and design grade. This ensured that water exited the pipe correctly and was safely slowed to prevent downstream erosion. A layer of filter fabric was placed over the area to separate the soil from the riprap, enhancing stability. The slopes and bottom of the swale were regraded for stabilization, and new riprap was installed at the inlet to protect against erosion caused by incoming flow. All disturbed areas, including the basin bottom, were stabilized using a seed mix, covered with erosion control blankets, and secured with sod staples to prevent future erosion.

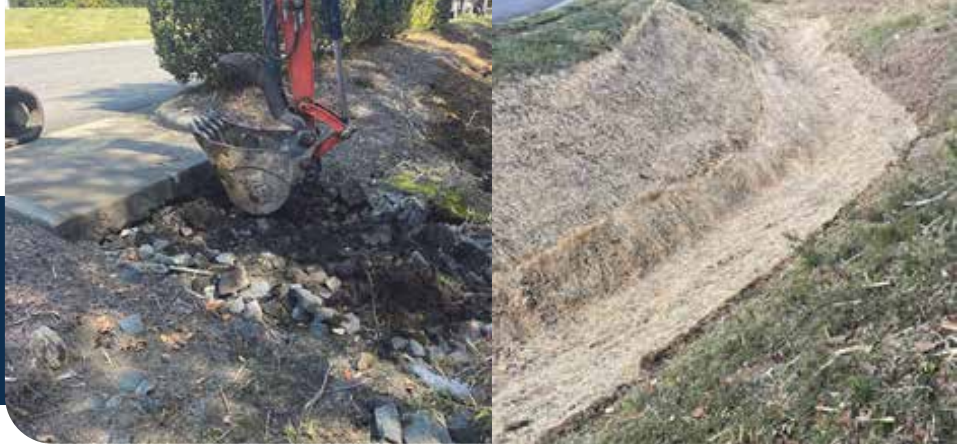
The detention basin also required restoration. Over time, woody-stemmed vegetation had grown throughout the pond basin. This type of overgrowth significantly reduces the pond's stormwater storage capacity, which is critical during heavy rain events. When dry ponds cannot store and control runoff as designed, the result can be standing water, or localized flooding, which poses risks to the property and can result in costly damage.

Another serious concern was a lack of a clear foot path to the control structure, which is essential for regular maintenance and inspections. Without proper access, inspection and maintenance are hindered, creating a safety hazard and compliance issues under local stormwater management standards. The structure must remain visible and accessible at all times to ensure the system functions correctly and can be serviced when needed.

To address the dry pond, the team used a brush hog to remove overgrown and woody-stemmed vegetation from the entire pond basin bottom, side slopes and dam crest. Concrete flumes were swept clean to remove any accumulated sediment. Around the outlet control structure, a combination of a brush hog, chainsaws and clippers were used to clear all surrounding overgrowth. This restoration ensured clear and safe access to the control structure, prevented future damage and brought the pond system back into compliance with stormwater regulations.
