MEBANE, NC

## INSUFFICIENT STORMWATER SYSTEMS

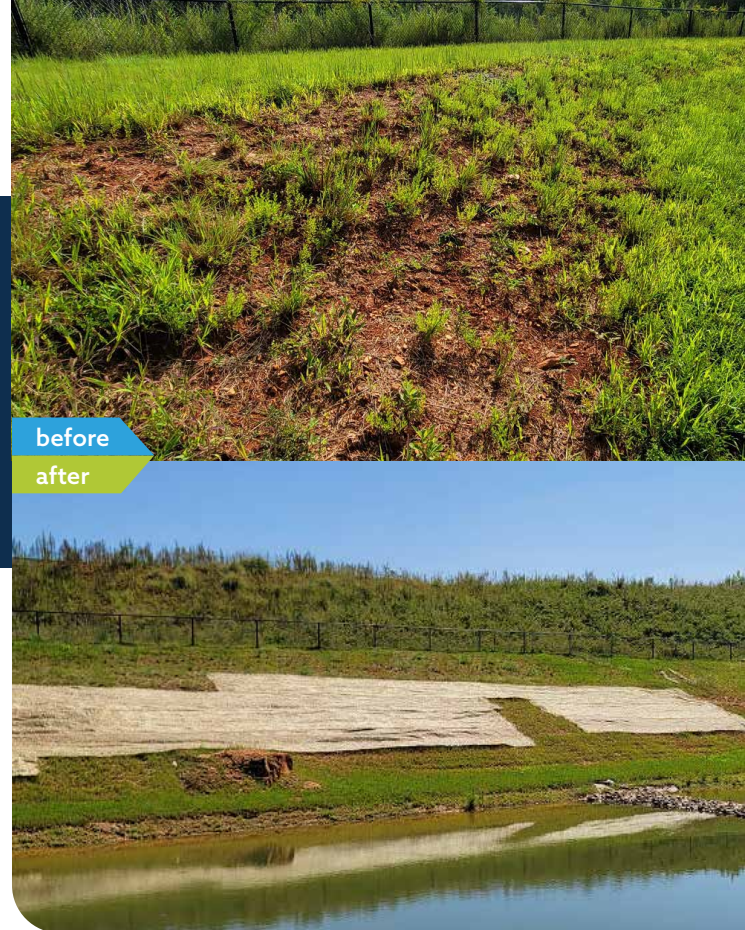
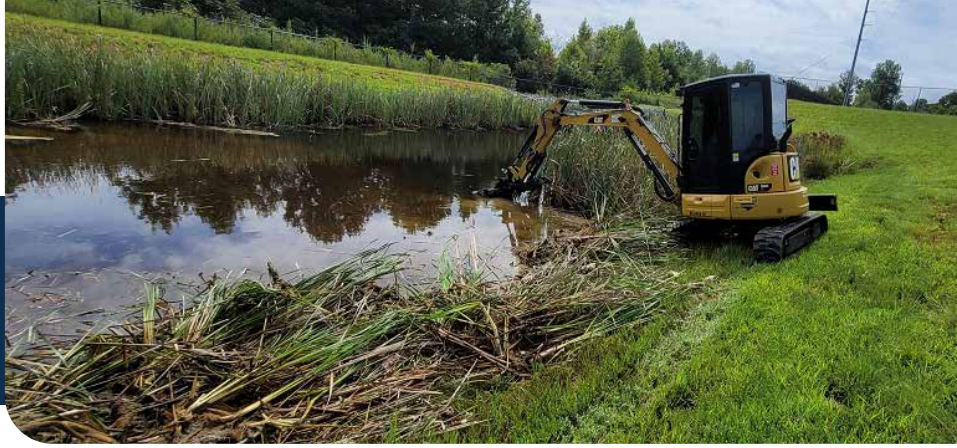
Two ponds on the property exhibited significant areas of bare vegetation and active erosion. Without proper treatment, these conditions escalate to increased sedimentation, and reduced pond capacity potentially causing safety hazards. Excessive sediment buildup in the ponds impacted their effectiveness and would have led to flooding. Understanding the potential for extended damage, the property owners agreed to conduct repairs now before full failure.

Pond 1, in particular, featured a monoculture of cattails along its banks, limiting vegetation diversity and potentially impacting habitat value. Cattails are an invasive species that can choke out beneficial vegetation within a system and harbor mosquitos. Additionally, vegetation around the pond's inlets was overgrown, causing restrictions to water flow and contributing to further erosion. The dissipator pad at the pipe opening was also missing. Dissipator pads are used to reduce the erosive force of stormwater runoff. A missing dissipator pad heavily contributes to water inlet velocity. Due to this missing component, incoming water eroded the area around the inlet pipes.

In pond 2, there was an overgrowth of vegetation within the spillway. A spillway was created so that water could flow freely over a dam during floods. However, the overgrowth of vegetation was preventing this process from properly happening, potentially increasing the risk of water backup or overtopping. Remnants of previous repairs also needed to be removed. These materials not only detracted from the overall appearance of the site but posed potential safety hazards and interfered with proper maintenance as well.

A missing dissipator pad at the pipe opening prevented proper water flow. Overgrowth threatened the stability of the ponds and necessitated restoration and erosion control measures. Several areas lacked sufficient soil, which prevented adequate nutrients from promoting healthy vegetation growth in bare areas. Lacking proper soil conditions increased the risk of continued erosion and sediment migration into the pond system.

This type of project is commonly performed by AQUALIS. Often municipalities require inspections every 3 or 5 years, which is a common timeframe for regular repairs. To start the project, pond 1 was scarified, meaning the team cut and removed debris using proper tools. The area was then treated with seed and erosion control matting. Team members used a mini excavator to remove all cattails that had overgrown in the littoral zone. The littoral zone is the shallow area near the shoreline of a body of water. Sunlight hits the bottom of this area, allowing aquatic plants to thrive, which is why regular maintenance of the littoral zone is essential. Bulk cattail clipping allowed access for dewatering and debris removal.

All overgrown vegetation around the inlet was cut and removed. The severely eroded area below the double-barrel HDPE (high-density polyethylene) pipes was regraded. These pipes are known for their durability and resistance to corrosion, making them ideal for stormwater applicators. After, the pond was stabilized with seeding and matting. A rip rap dissipator was installed in front of the pipes to help prevent future erosion, and filter fabric was placed below the new dissipator pad.

Team members stabilized all bare areas along the interior embankment of Pond 2, using seed and matting. Overgrown vegetation was removed from the spillway, restoring proper water flow. Team members removed all trash and debris from the fence line for disposal. Following final cleanup and demobilization, the team left the property in significantly improved condition. Both ponds were successfully restored to proper working order, ensuring compliance and reducing the risk of future erosion or flooding.
