AQUALIS

ORLANDO, FL.

POND REPAIR AND SOLVING EROSION & COMPLIANCE ISSUES

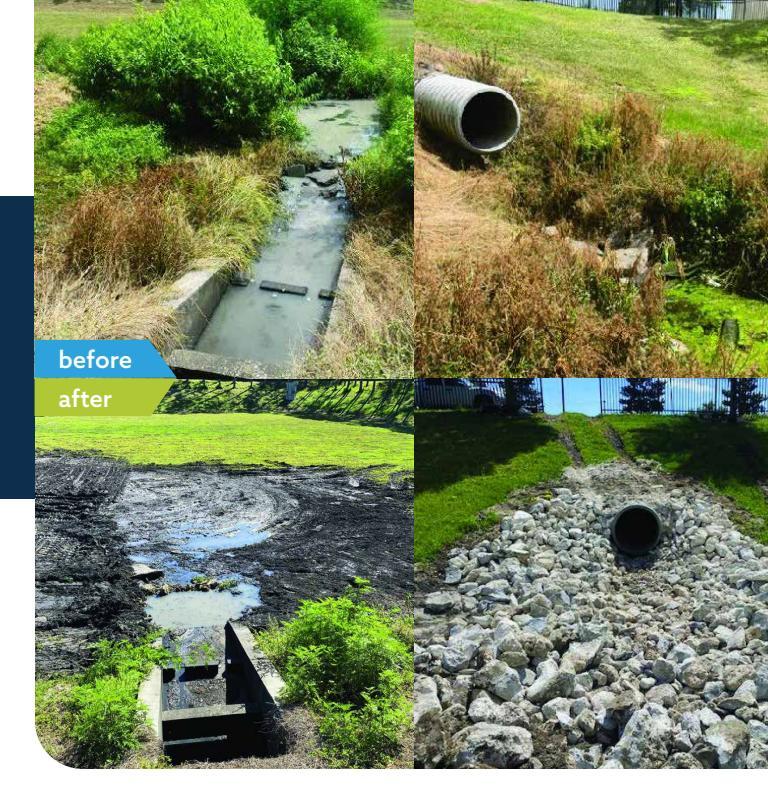
On this property, the ponds had begun to suffer from lack of maintenance. Clearing out

the clogged media was necessary for the four ponds. Some ponds required full excavation, regrading the entire bottom layer while some only needed excavation around structures.

This property suffered from significant erosion and sediment displacement. Erosion is the process of sediment loosening and being moved due to fast moving water. During significant rain events, water can overwhelm stormwater control measures, bypassing outlets. The strong velocity can lead to erosion as the repeated pattern of overflow removes more and more sediment. This sediment is then deposited downstream, disrupting the natural flow of water. The excess sediment, vegetation and debris naturally flows to the dry ponds where it adds to the clogging of the asset.

Large root systems and woody vegetation in a pond is another indicator of a failing pond. Both wet and dry ponds should generally be free of trees and bushes inside the basin. Large vegetation with extensive root systems disrupts the design, structural integrity, stability and natural filtration of retention ponds and may monopolize beneficial vegetation.

To repair the ponds, the experts at AQUALIS began by clearing and excavating the necessary areas. Overgrown vegetation and sediment were removed from all four ponds to be disposed of offsite. Underdrain repairs were then conducted, replacing sections and cleanout caps as necessary. Then each pond could be repaired back to the original design with filtering media, stabilization matting and seed. To repair outlets and junctions that experienced erosion, AQUALIS corrected any structural deficiencies, regraded and installed rip rap to protect from further soil displacement. Rip rap is intentionally placed rocks that disrupt fast moving water, slowing the velocity to allow for proper energy dissipation.

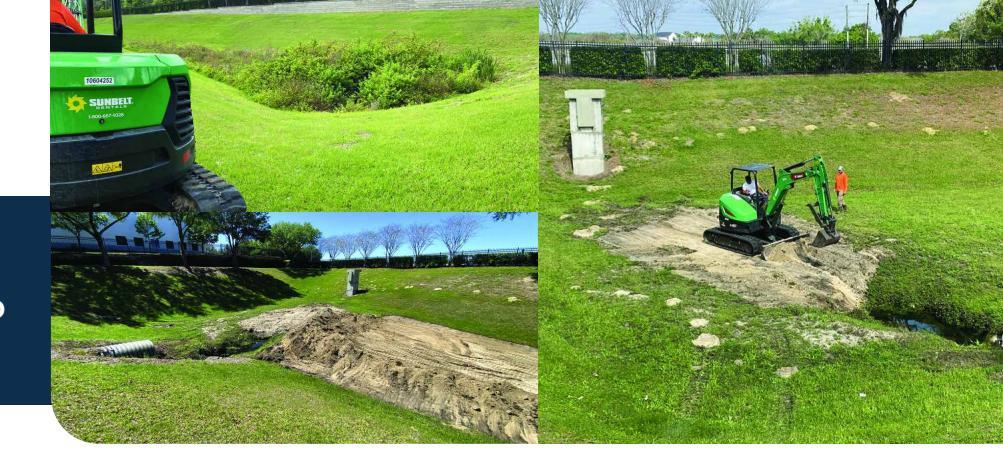
Ponds 1, 2 and 3 on this property suffered from damaged underdrains. Underdrains are a component of some ponds that aid in conveying stormwater out of the pond and further downstream at a controlled rate. Ponds can function without them, but they are additions on some properties based on site variables and design conditions. The underdrain in pond 1 had numerous sections of exposed or damaged pipe that needed to be repaired, reconnected and buried. During the excavation stage, the underdrain system was exposed to allow access for inspection and repairs. Underdrains are most often constructed from PVC pipes and often buried only 6 inches under the surface, making replacements relatively easy. After the damaged components were removed, new lengths of pipe could be secured and buried at the appropriate grade.

The underdrains in ponds 2 and 3 suffered damage to the cleanout sections, which are the vertical pieces of pipe visible above ground that allow access for cleaning and inspection. Because the cleanout sections protrude out of the ground, they are susceptible to damage from lawnmowers. It is extremely important for certified stormwater professionals to maintain stormwater control measures to avoid mishaps like this. Dry retention ponds may just look like a patch of grass, but they are specifically engineered to improve water quality and should be regularly maintained by stormwater professionals.
