PERMEABLE PAVEMENTS MAINTENANCE AND REHABILITATION

CASE STUDY

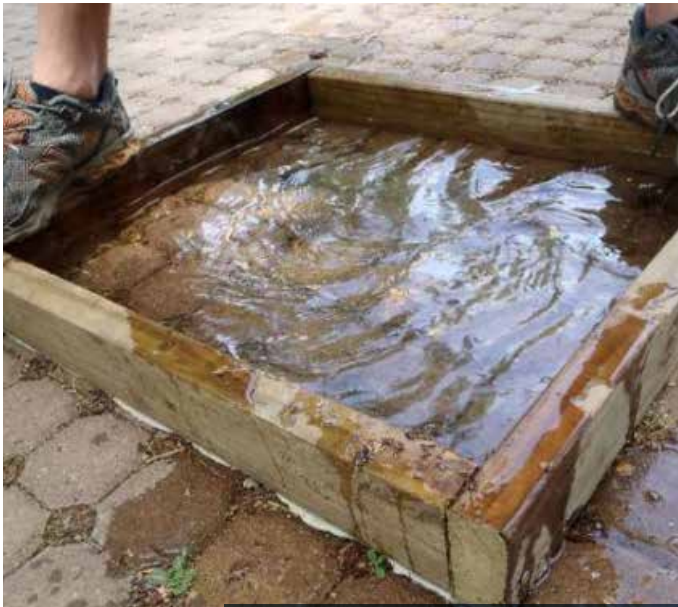
ASTM C1781 test involves measuring the drawdown rate of a section of pavement.

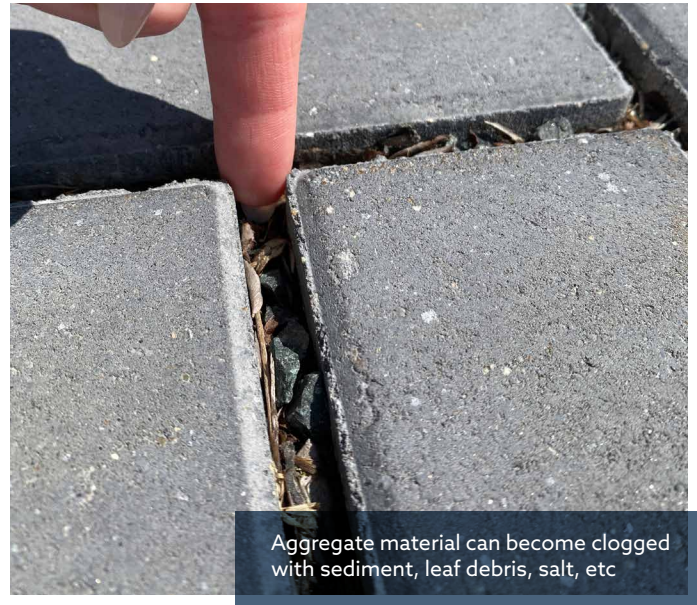
Aggregate material can become clogged with sediment, leaf debris, salt, etc

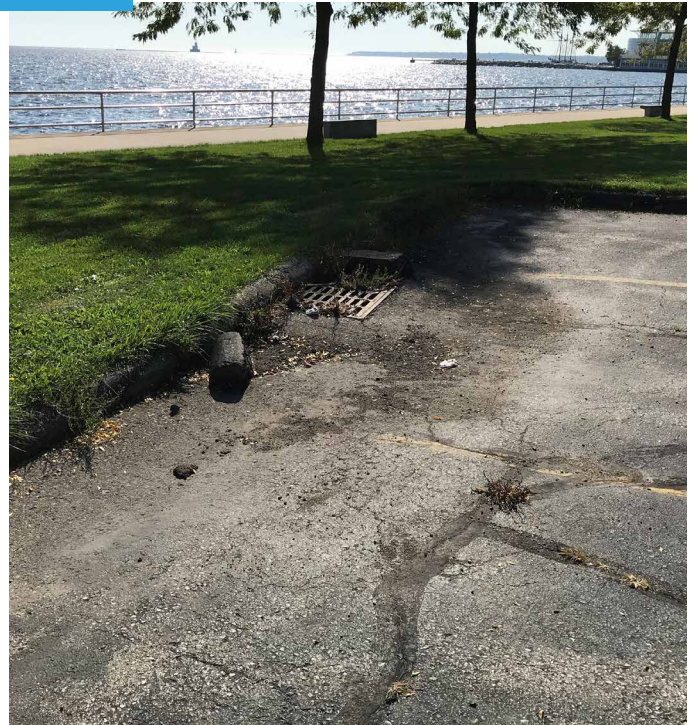
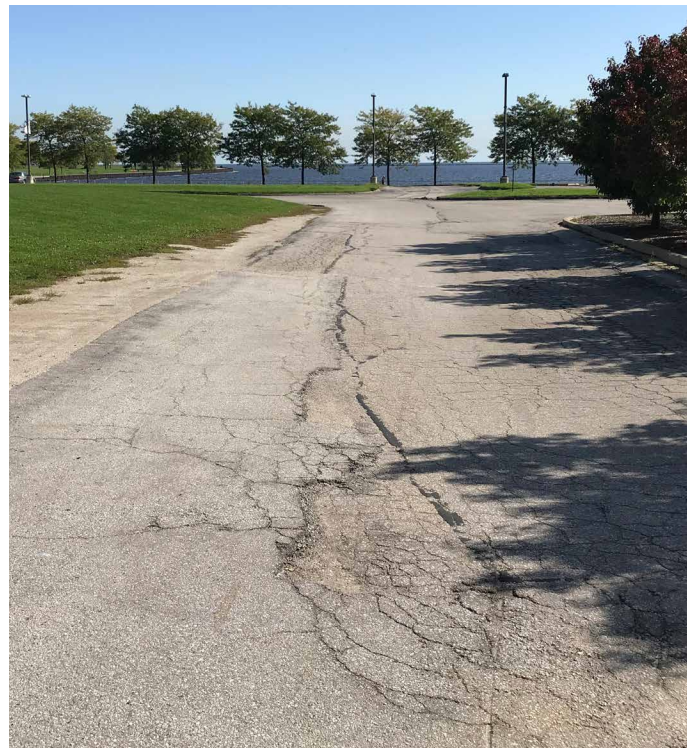
BEFORE

The site had three sections of permeable pavement. Initial inspection results were that some areas, particularly the low spots in the permeable pavement areas, were significantly clogged with sediment. The most extreme clogging occurred at a section that has a significant slope. To judge the level of clogging and therefore cleaning necessary, AQUALIS conducted an infiltration test (ASTM 1781). Both downstream and middle locations **failed to meet performance standards** of greater than 10 inches per hour.

The upstream section remained functional, reinforcing a common stormwater pattern: **sediment accumulation increases as runoff flows downslope**, clogging lower pavement areas first.

While routine litter control and vegetation inspections were already in place, AQUALIS recommended enhancements to prevent future clogging including parking lot sweeping after fall leaf drop and spring snow removal. Bi-annual sweeping will prevent the accumulation of sediment that runs into and clogs the pavers.

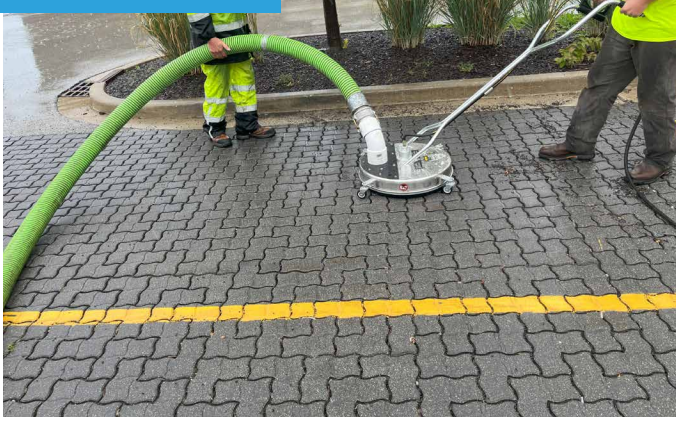
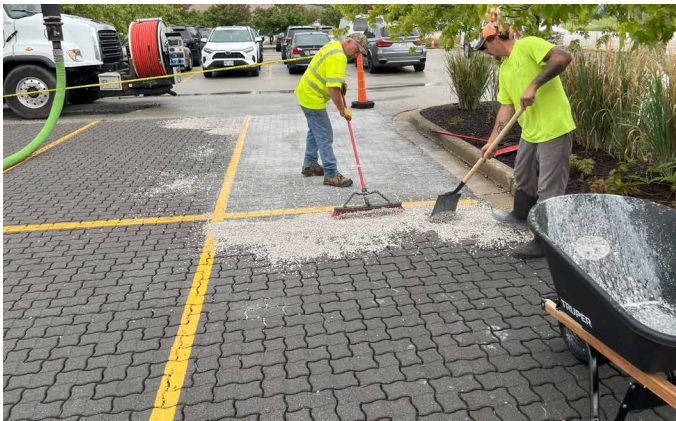
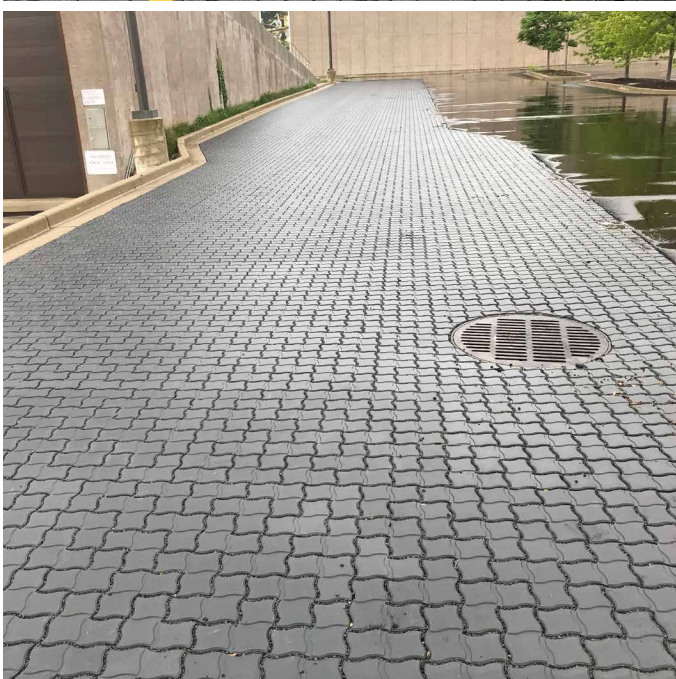
DURING AND AFTER

Maintenance of the permeable pavers was conducted using a high-pressure washer and vacuum surface cleaner. The high-pressure washer breaks up and loosens compacted sediment so the vacuum could remove the sediment and clogged joint stone. After the clogged joint material and debris were removed, new clean joint material was swept into the joints.

After maintenance, infiltration rates increased more than 20 to 70 times in previously clogged areas. Removing clogged joint material and replacing it with clean aggregate proved highly effective, immediately restoring system performance.

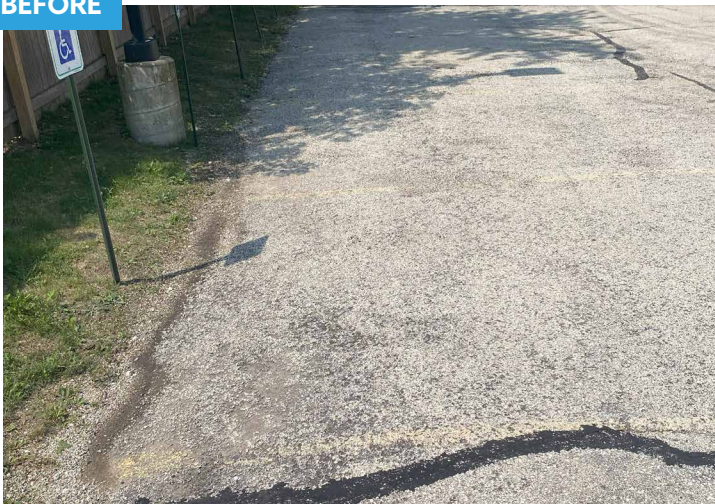
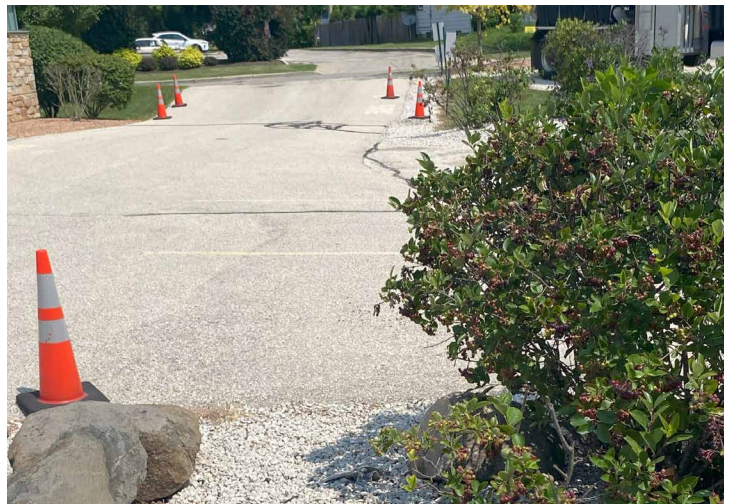
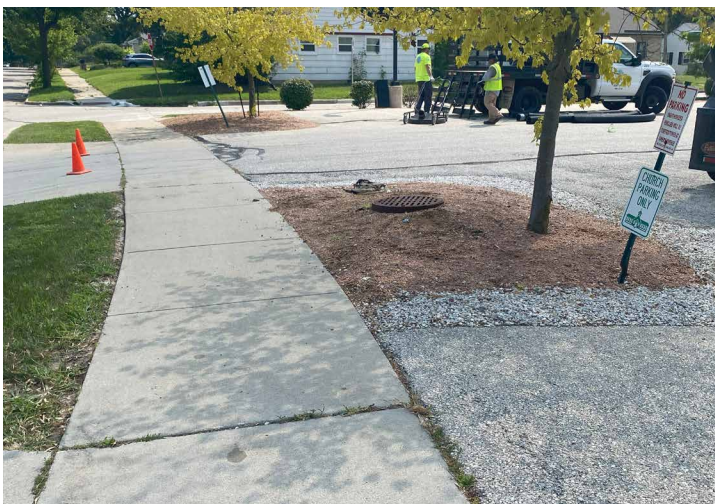
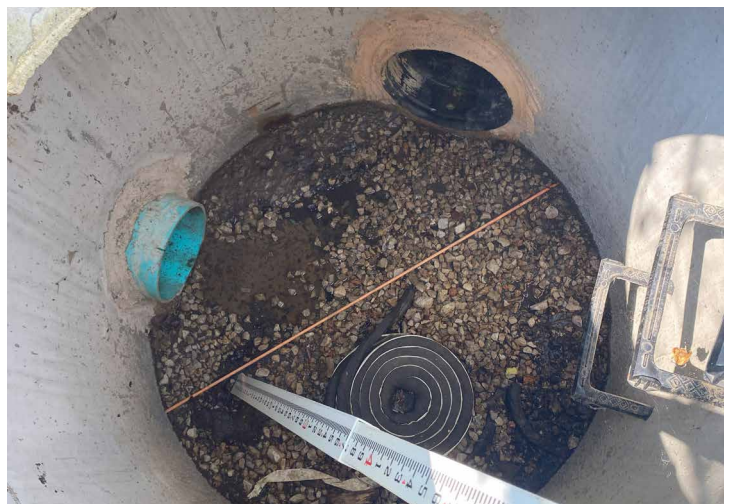
BEFORE

An initial inspection was conducted, and the porous asphalt was visibly clogged with sediment. The pavement was installed in 2006 and is at the end of its expected design life, and it is evident that maintenance was not regularly conducted. An infiltration test was performed in accordance with ASTM C1701. This test showed the asphalt failed to infiltrate.

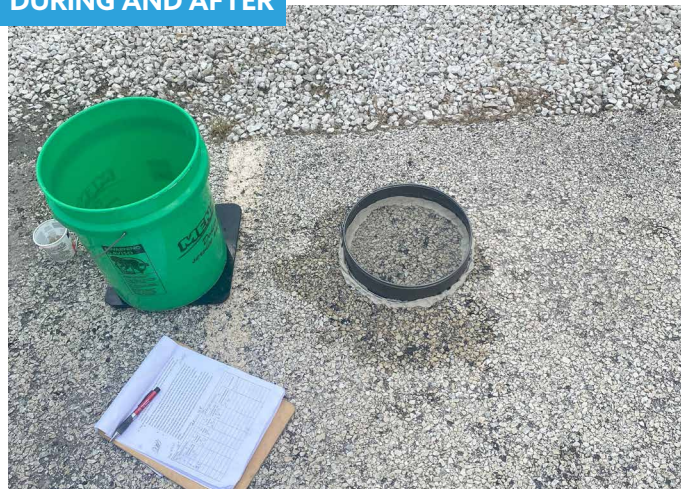
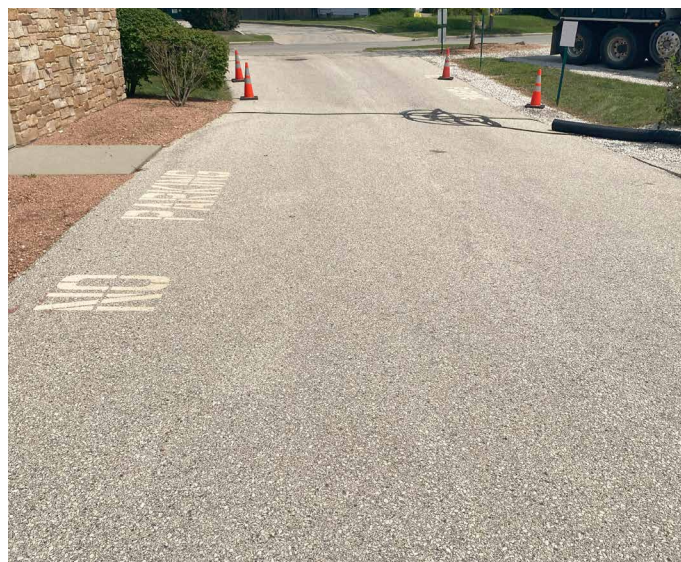
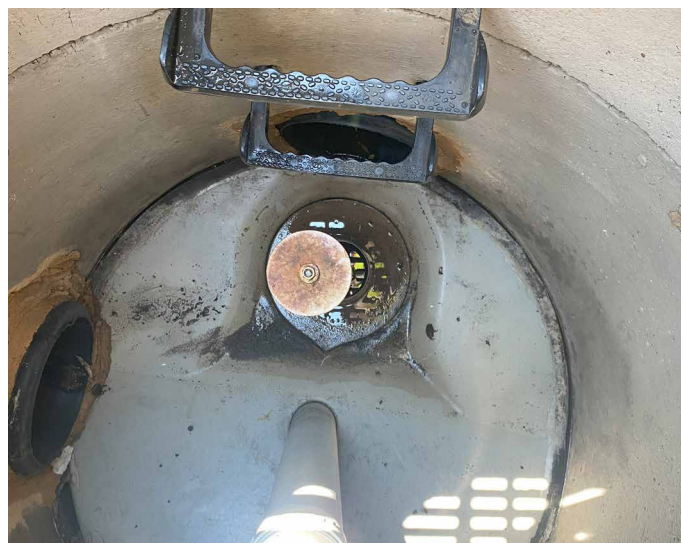
DURING AND AFTER

Maintenance of the porous asphalt was performed with a high-pressure washer and vacuum surface cleaner. Infiltration testing was conducted after the first pass of the surface cleaner. After the first cleaning pass, the surface remained visibly clogged and infiltration testing again showed **no measurable infiltration**. To evaluate whether additional effort could improve performance, one area was cleaned more aggressively. A follow-up infiltration test in this area produced an infiltration rate of **6.7 inches per hour**, which remained below the required **10 inches per hour** standard. The aggressively cleaned area was the **only location where water visibly drained**.

Research and industry experience indicate that the **top 2 centimeters** of porous asphalt are most impacted by sediment clogging. One effective rehabilitation approach is to:

- Mill off the top 2 centimeters of pavement
- Replace with a new porous asphalt surface layer

This process removes clogged pore space entirely and restores infiltration capacity. With routine maintenance following rehabilitation, pavement life can be extended approximately **10 additional years** before full replacement is required.

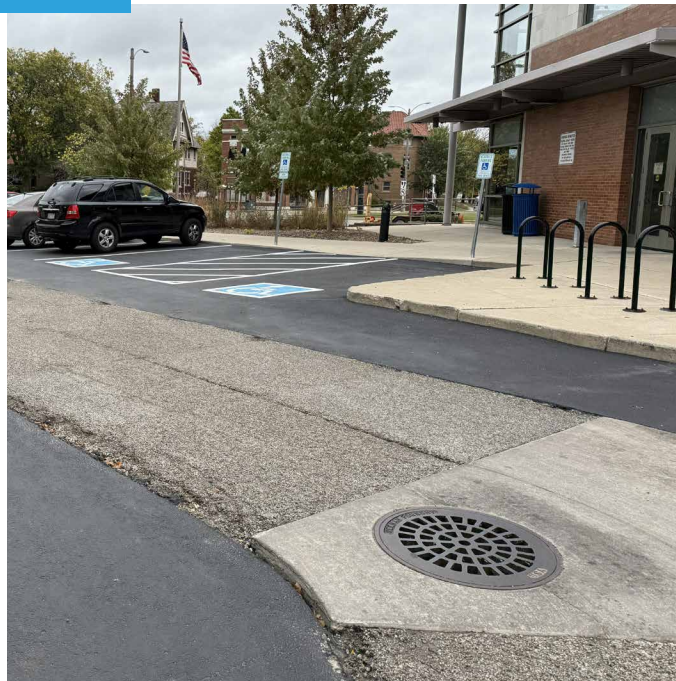
BEFORE

An initial inspection revealed the pervious concrete was visibly clogged with sediment, indicating a lack of regular maintenance since its installation in 2018. The surface no longer appeared to be functioning as designed for effective stormwater infiltration.

At the edge between the pervious concrete and adjacent asphalt pavement, multiple potholes were observed. These were likely the result of material deterioration caused by prolonged exposure to excessive deicing salts. Additionally, a noticeable accumulation of sediment was present along the boundary areas. This sediment buildup appeared to be associated with recent mill-and-overlay work on the adjacent asphalt, where the new asphalt surface does not match the grade of the existing pervious concrete. The resulting elevation difference has created drainage issues, preventing water from flowing properly onto the pervious concrete in some areas.

Basic maintenance at a minimum of two times per year (Spring and Fall) will prevent build up above and below the surface. More frequent cleaning may be necessary based on site conditions and adjacent ground/pavement surfaces.

Since the pervious pavement at this site is failing and has not been maintained for years, our recommendation is to remove the current porous concrete system and replace it with either a similar pre-cast pervious concrete slab system, permeable pavers or a pre-treatment device that directs the flow through the stone storage layer.
