JACKSONVILLE, FLA.
COMMERCIAL
STORMWATER SYSTEM REPAIRS

JACKSONVILLE, FLA. WET DETENTION POND REHABILITATION

A wet detention pond located adjacent to a shipping and transportation warehouse required corrective action to restore access for maintenance. AQUALIS utilized a swift, environmentally conscious solution to rehabilitate the pond and ensure proper maintenance moving forward.

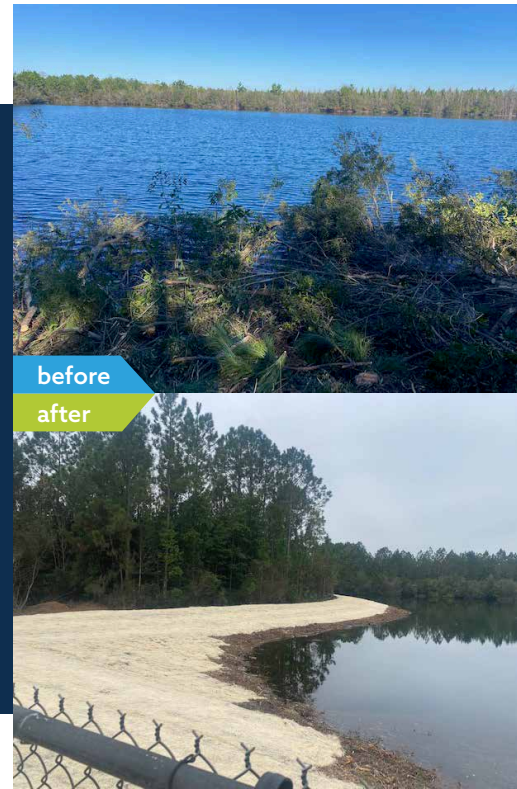
A large detention pond in Jacksonville, Fla. required a clearing and regrading due to the overgrowth of vegetation along the pond's shallow land buffer, littoral shelf and compacted earthen structures. This heavy slash pine proliferation and maturation impacted the property owner's ability to effectively maintain, mow and make corrective repairs to the pond. Failure to properly maintain the pond could have quickly led to the risk of erosion and perforation of earthen structures that could threaten the nearby area.

Time was of the essence for this project, as the longer the overgrowth was allowed to proliferate, the more devastating the impact would be on both system functionality and the surrounding area. If a lack of routine maintenance and vegetation management is prolonged, the shoreline is at risk of erosion, due to water improperly moving from roots of the invasive vegetation to sections of the pond ill-equipped to deal with runoff, such as the embankment. Erosion can cause complete system failure, as proper drainage and water filtration is impeded, which can lead to sedimentation clogging the system and steep banks or landscape indentations to form around the pond.
