ATHENS, GA RETAIL STORMWATER MANAGEMENT

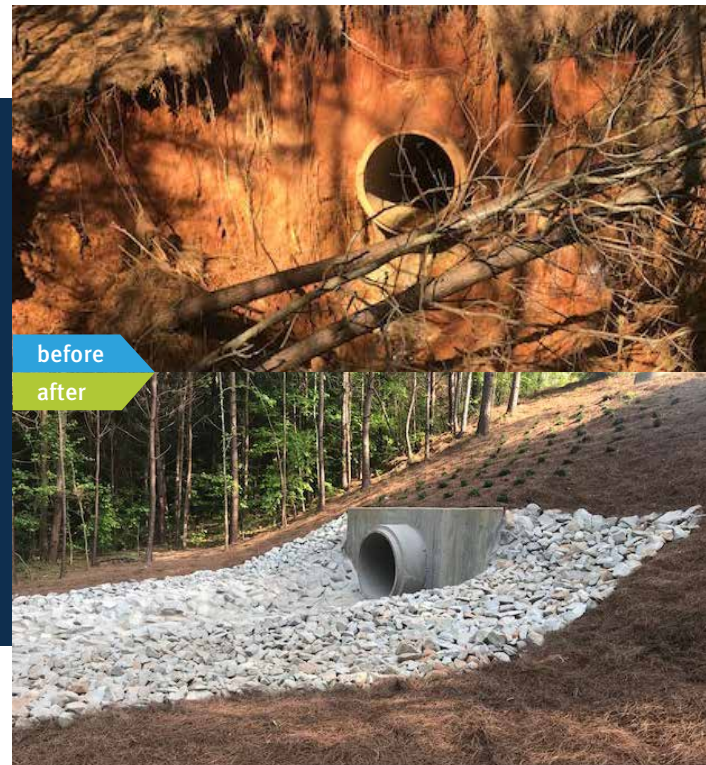
In Athens, Georgia a store's stormwater detention pond outlet was being affected by substantial erosion. Trees surrounding the area had grown too large for their proximity to the outlet. This allowed roots to entangle themselves with the outlet pipe as the tree continued to grow. The roots grew with time as well, and eventually caused a washout and collapse of the pipe.

A section of pipe approximately 20' of 60" in size became completely detached. This allowed water to flow freely over unprotected soil, leading to the massive eroded area. During heavy rain events, erosion patterns caused water to swirl in front of the outlet leading to more intense erosion and compromised the soil integrity of the entire area. It was concluded that the entire slop would need to be reconstructed to ensure stabilization.

AQUALIS experts new the first step was to remove the source of the problem, overgrown vegetation. The trees were cut down and the entirety of the plants were removed, stumps and root systems included. This was done to ensure the repair efforts would not be subdued by tree roots in the same way as the original pipe.

Once the area was cleared, the pond had to be drained to allow pipe access, inspection, and proper reconstruction.

Next, sediment and debris were removed from the eroded area. Any good dirt, referring to dry and compactible, found was saved and used later in the reconstruction.

Reshaping and grading then prepared the outlet area for dredge sox, rocks, and the new pipe. Soil was compacted every 2 feet for stabilization, until built grade was met. Geo-textile liner and riprap were used during the rebuilding of the outlet to ensure stability and minimize future erosion as preventive measures. A new headwall was constructed to thwart vegetation growth and erosion, so this location does not face the same problem again. Once the slope was completely reshaped, any areas of concern were stabilized with love grass and erosion control blankets.

Finally, any disturbances to the pond were repaired, fencing was reinstalled, and the area was seeded with Love grass and Juniper.
