DURHAM, N.C.

SINKHOLE LEADS TO STORMWATER SYSTEM REHABILITATION

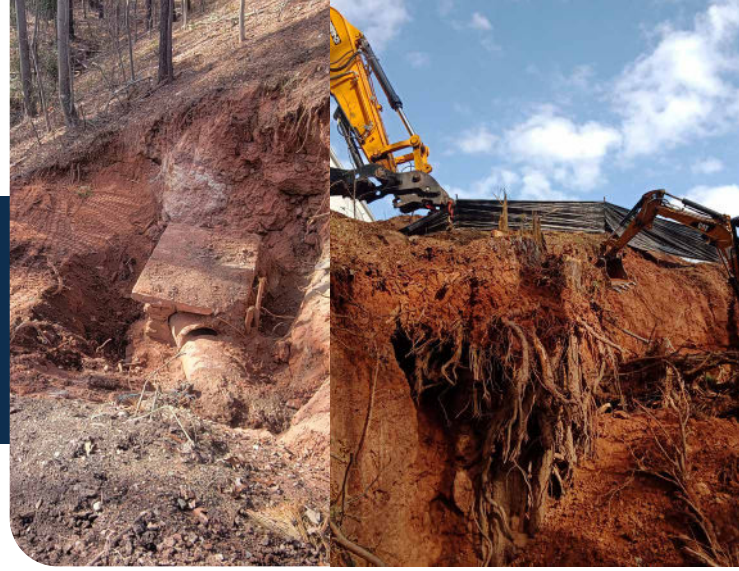
pipeline allowing the stormwater inside to divert from the pipe. With mature trees, unstable soils and a severe slope to quicken the flow of water, multiple catalysts for decay were present.

AQUALIS established bypass lines for the stormwater system to maintain functionality throughout the repair. The concrete pipeline was severely eroded, leaving large holes as it collapsed. The original junction boxes were created from brick. While this may have been an approved method in the mid-80's when the system was originally developed, it is no longer recommended as cast-in-place and/or pre-cast withstands overtime. The joints that originally connected the pipeline and the junction boxes had failed. The failed junction box was removed, and the new junction box was cast in place using concrete. The second junction box was repaired and reinforced with grout and concrete. The new pipeline was then laid. Every joint of the pipeline was reinforced with additional concrete to prevent future seepage. The concrete headwall was then repaired.

Shoring was also required due to the proximity of the building to the construction area and the amount of soft soils found within the geophysical area around and underneath the building. The shoring prevents the building from sliding down the slope as the soils are volatile. Shoring is the process of installing large, prefabricated steel beams perpendicular to the surface to support the weight of the slope or excavation area. These steel beams are driven into the ground with a vibrational hammer and offer structural support, like a retaining wall. The depth of the piles is decided by the ratio of the slope and excavation area.

Once the structures were repaired and replaced, they could then be buried. Due to the unstable natural of the soil, over 600 cubic yards of supplemental soil was brought on site to offer additional stability and meet the suitable engineer fill requirements. Then, the soil was compacted to prevent future erosion.
