AUSTIN, TX.

CURED IN PLACE PIPE

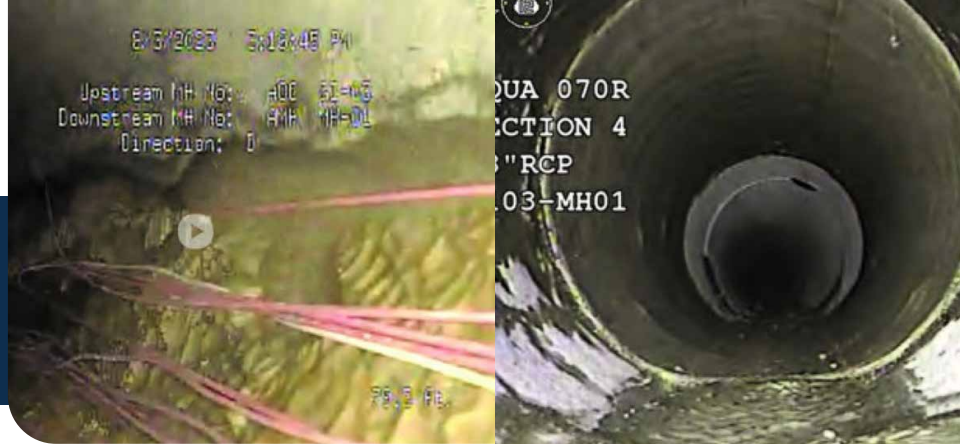
During the camera investigation, the operator found extensive blockages inside the pipeline. Construction debris, including PVC pipe, wires and concrete, had been deposited inside the pipe, significantly reducing capacity, leading to clogging. Because of regular clogging, the pipe was under consistent stress that rapidly deteriorated the infrastructure. In addition to the wire and PVC pipe that was found, significant damage and concrete debris was found as the pipe crumbled from the inside.

The pipeline, made out of reinforced concrete pipe (RCP), was experiencing failure so great, the rebar reinforcements inside the concrete were visible. The internal rebar was beginning to corrode resulting in further damage to the structure. Large gaps were visible between sections of pipeline, allowing surrounding sediment into the pipeline and to the retention area downstream. This process is the leading cause of sinkholes as rushing water displaces the dirt creating a cavity that eventually opens at the surface.

AQUALIS CCTV Pipe Inspections follow the industry standard rating scale of 1-5 as set by NASSCO. Significant defects that require immediate attention are labeled 5 while minor issues are labeled 1. The pipeline assessment showed four different sections of about four feet each that required immediate repair. To avoid replacing the entire pipeline, cured-in-place-pipe (CIPP) repair was chosen, allowing for small spot repairs.

Once the initial CCTV assessment was conducted and the obstructions were identified, the operators had a better understanding of how to complete the repair. Industrial vacuumation and jetting was sufficient for removing the concrete debris and PVC pipe, but a root cutter was deployed to cut the wires. After the pipe was cleared, the repair could be performed.

CIPP allows for trenchless point repairs, significantly reducing construction costs. CIPP repair is performed by inserting a resin coated liner into the existing pipe. The liner

is then inflated to cover the internal wall of the pipe, it can then be cured with steam, water or UV technology. Using CIPP to patch repair this pipe saved the property from fully replacing the pipeline and extended the life of the infrastructure another 50 years with maintenance.
