PERMEABLE PAVEMENTS MAINTENANCE AND REHABILITATION

CASE STUDY

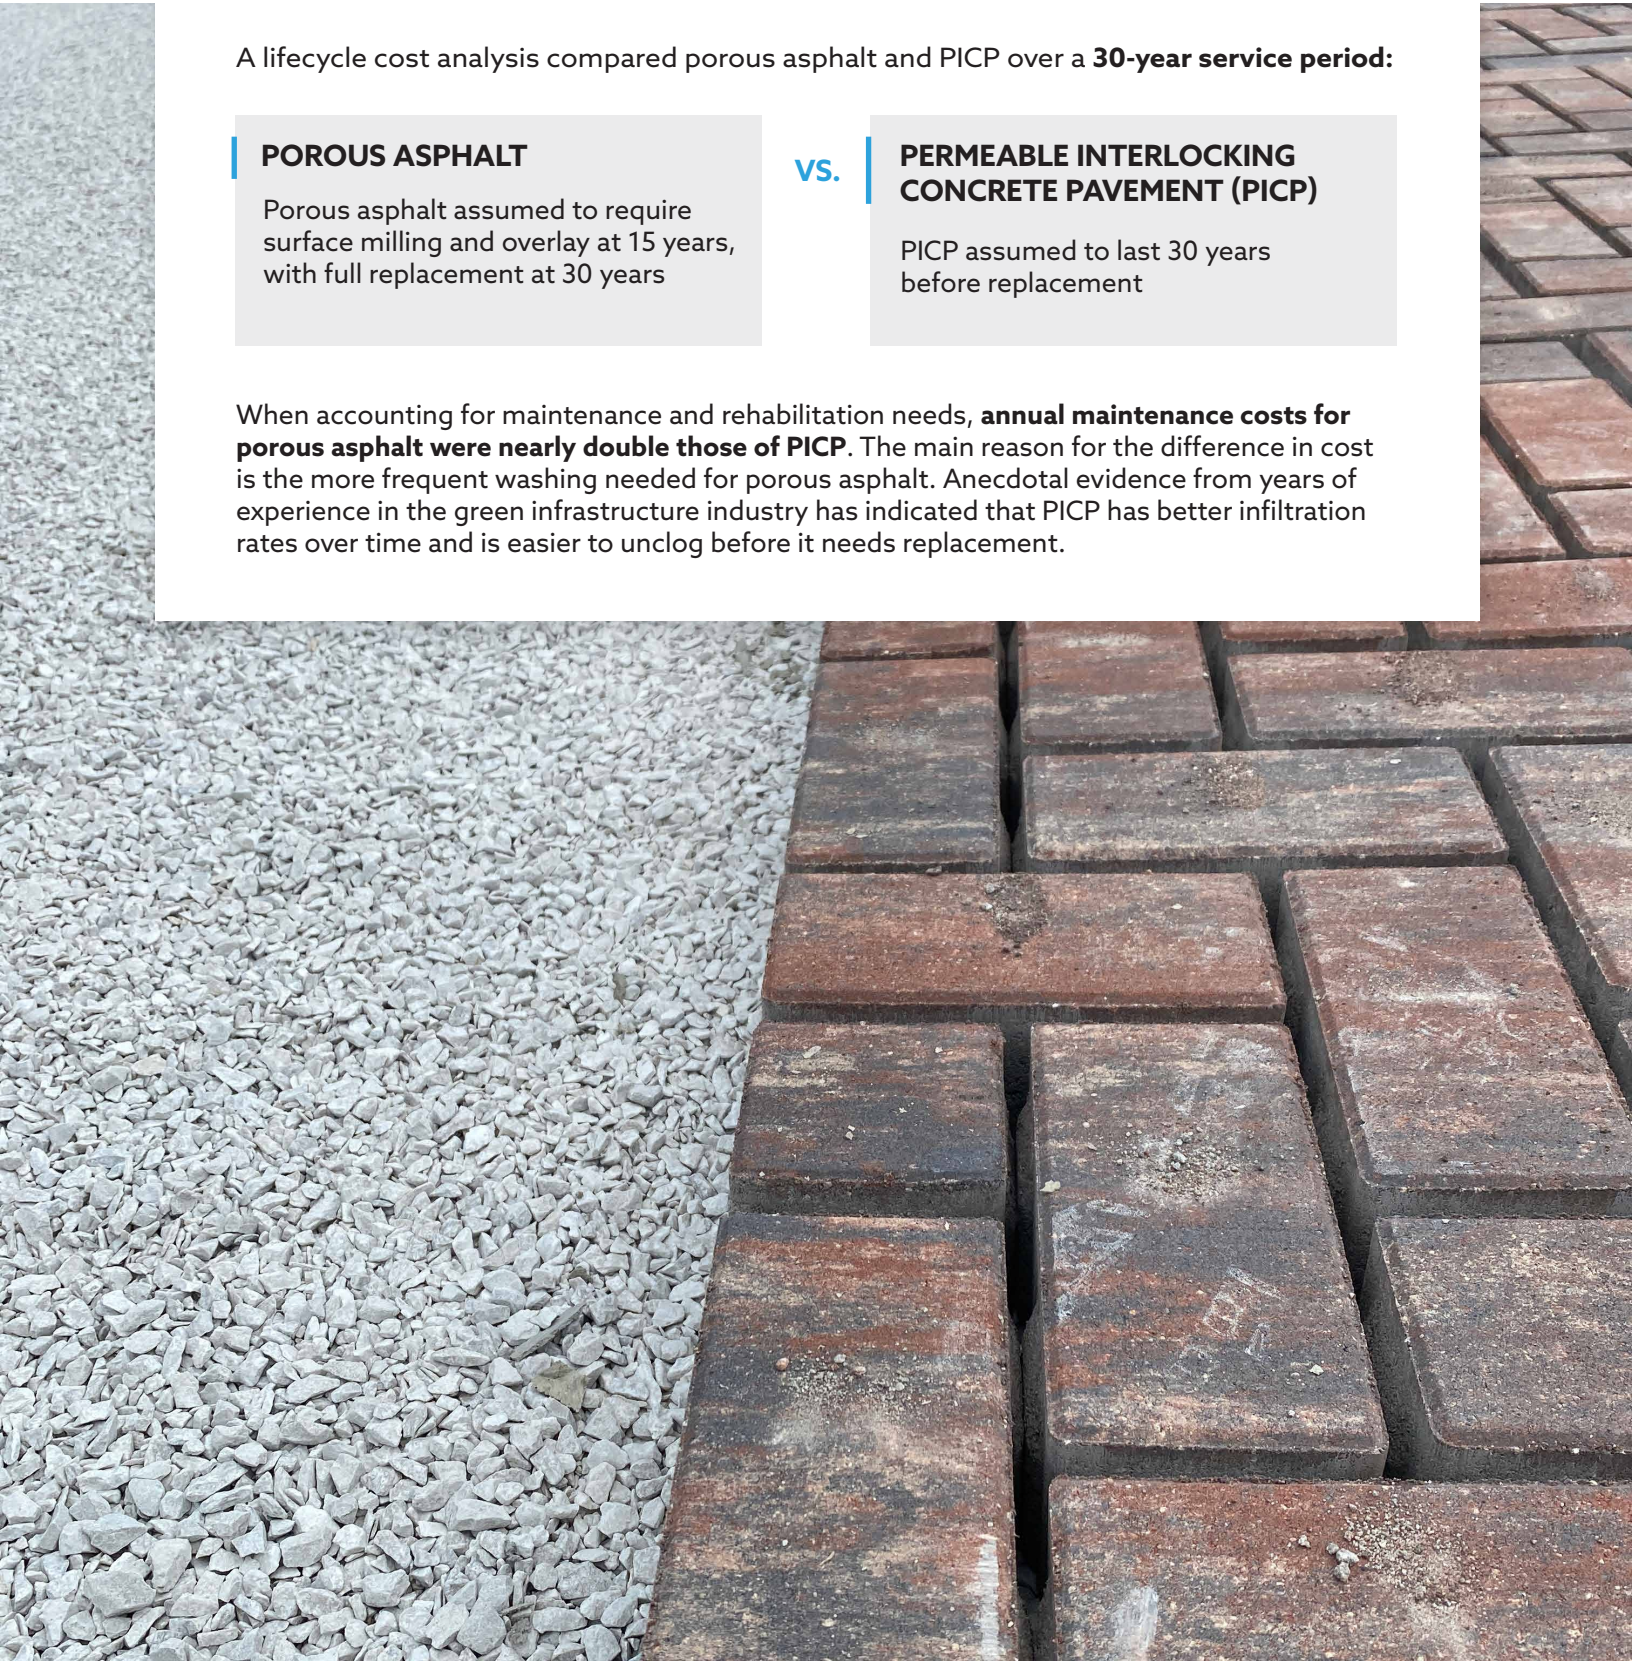
An initial inspection revealed the pervious concrete was visibly clogged with sediment, indicating a lack of regular maintenance since its installation in 2018. The surface no longer appeared to be functioning as designed for effective stormwater infiltration.

At the edge between the pervious concrete and adjacent asphalt pavement, multiple potholes were observed. These were likely the result of material deterioration caused by prolonged exposure to excessive deicing salts. Additionally, a noticeable accumulation of sediment was present along the boundary areas. This sediment buildup appeared to be associated with recent mill-and-overlay work on the adjacent asphalt, where the new asphalt surface does not match the grade of the existing pervious concrete. The resulting elevation difference has created drainage issues, preventing water from flowing properly onto the pervious concrete in some areas.

Basic maintenance at a minimum of two times per year (Spring and Fall) will prevent build up above and below the surface. More frequent cleaning may be necessary based on site conditions and adjacent ground/pavement surfaces.
