LAKWOOD, WA  
RETAIL  
STORMWATER MANAGEMENT

## GRAZING GOATS HELP CORRECT EXCESSIVE BLACKBERRY GROWTH

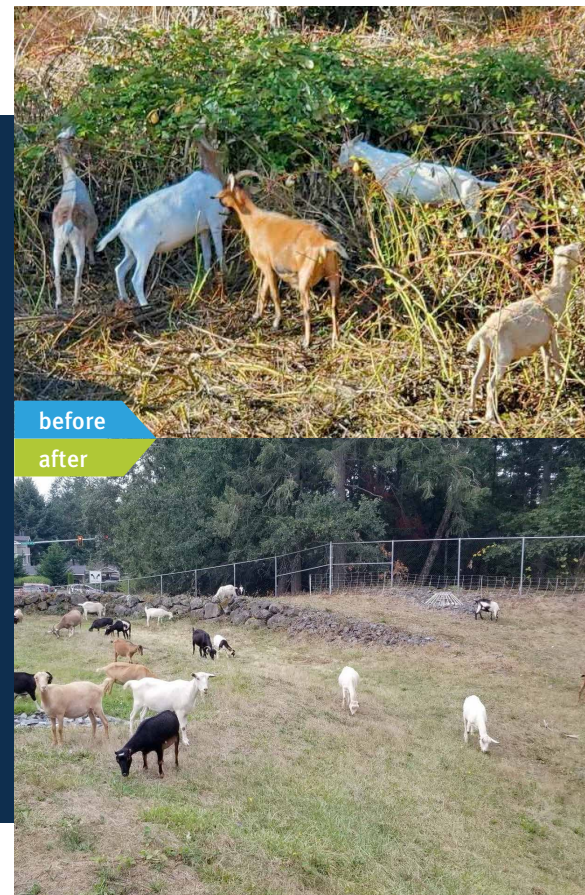
This Northwest Washington store was experiencing excessive overgrowth of Himalayan blackberries, about 40,000 sq. ft, along the slopes of an existing vegetative stormwater detention/infiltration asset. Himalayan blackberries are identified by the Washington Weed Control Board as a nuisance weed. When unmanaged, they can cause dense thickets of vegetation that become very hard to manage, can make stormwater assets difficult to access, and dominate over native vegetation that provide natural ecosystem benefits. Himalayan blackberries encroaching on the stormwater asset will leave the asset vulnerable to flooding from excess debris and sediment build-up near the base and would not allow the native vegetation to absorb and filter runoff. Overgrown vegetation along a slope can also cause soil erosion.

The solution to use grazing goats was chosen to correct the issue of excessive Himalayan blackberry growth along the slopes of this stormwater asset. Goats are a useful approach to managing Himalayan blackberries because they can counter-act the aggressive characteristics of the bush. Goats assist in blackberry removal by grazing, and ultimately removing, the entirety of the plant year-round, including the thorns. This alternative is less costly than using herbicides or mechanical controls. Some manual vegetation removal was required for the taller growth.

AQUALIS began by organizing all the equipment and labor to the site. The goats were then directed to the site, where they began to remove the blackberry leaves and stalks from the slopes. A shepherd was kept onsite (including overnight) to look after and care for the goats. A fence was installed prior to releasing them to focus the goats and their grazing patterns. Along with the functioning work of the goats, they were also a joy for the community. The goats were all rescues that worked part of the year and resided in a safe shelter on Vashon Island the other part of the year.
